LOSS REPORT Final

Reference: Report #: 1 Catastrophe Number: 00516 Policy Number: 1234567890 Claim Number: 005-0004004-2012 Insured: John Smith Date of Loss: 6/29/2012 1234 Avenue D Type of Loss: Wind Damage Wapakoneta, OH 45895 File Number: **ENCLOSURES:** Estimate, Statement of Loss, Photos (1), Diagrams **COVERAGE:** Eff. Dates: From: 4/1/2012 To: 4/1/2013 Dwelling \$208,000.00 Lima Superior Federal Credit Union Mortgagee: Other Structures \$31,200.00 Deductible: \$500.00 Contents \$145,600.00 Co-Ins. Policy: Yes 🗌 No 🖾 Forms: Ordinance Or Law \$20,800.00 Tree Debris \$500.00 Removal

FINAL REPORT

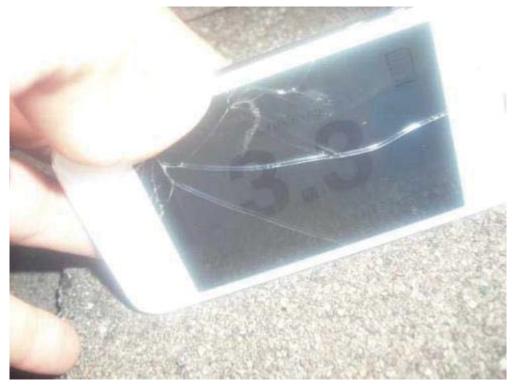
1

The roof had a 3/12 pitch.

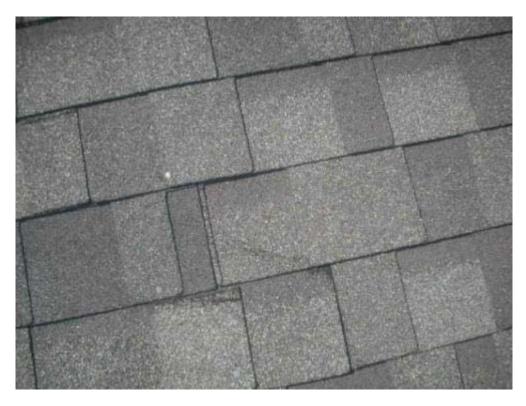
9

Overview of wind damage and temporary repair.

(1) **Roof**: I began my inspection with the roof. The 3 year old 30 year dimensional shingle on the roof sustained wind damage on the back slopes. There was no visible damage to the front slope. Due to the wind damage, I am recommending the back slopes for replacement. Ice and water shield was not on the roof but the policy has the 17555 endorsement so I included this upgrade and held back the full amount until the cost is incurred. I also included the allowance for cutting the tree debris off of the roof.

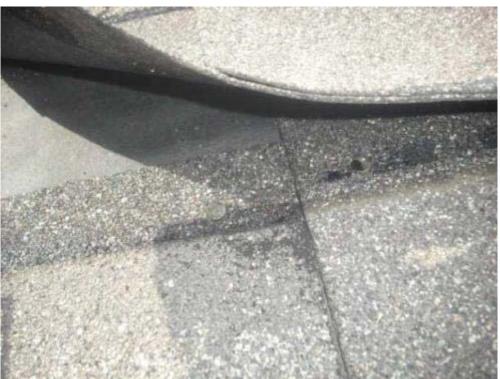
Date Taken: 4/20/2012 Taken By: CSI Representative Overview of wind damage.

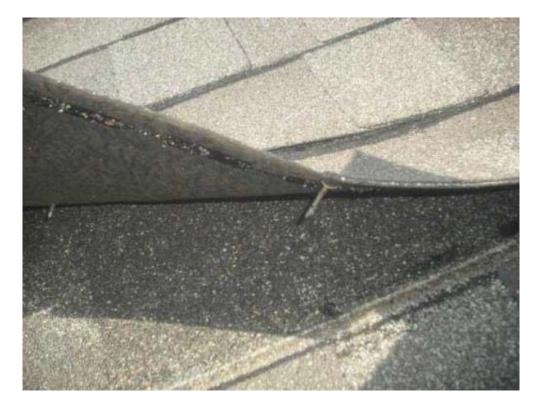
11

Overview of wind damage.

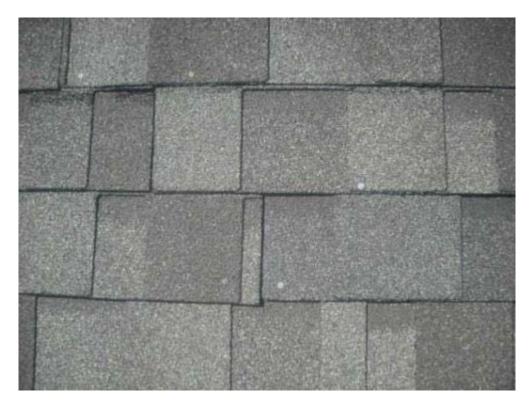
13

Overview of wind damage and temporary repair.

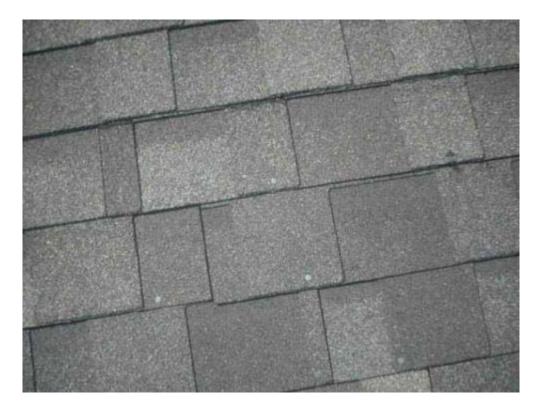
15

Overview of wind damage and temporary repair.

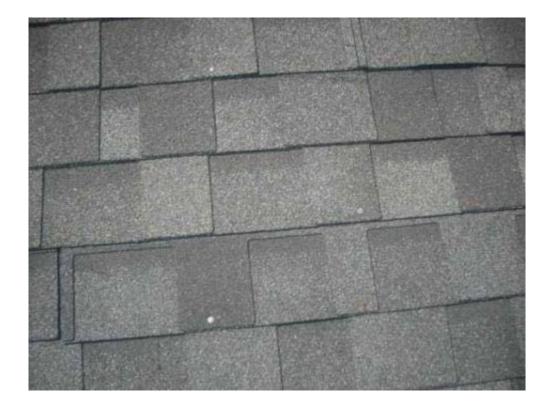
17

Overview of wind damage and temporary repair.

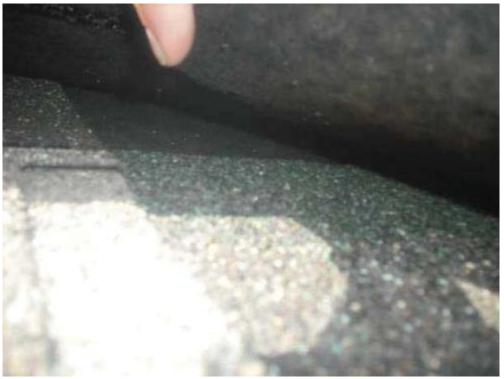
18

Date Taken: 4/20/2012 Taken By: CSI Representative Overview of wind damage.

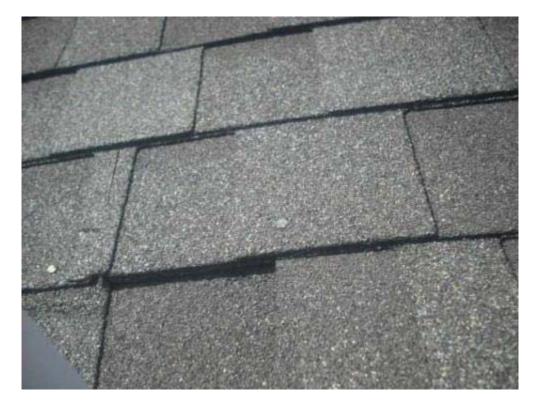
19

Overview of wind damage and temporary repair.

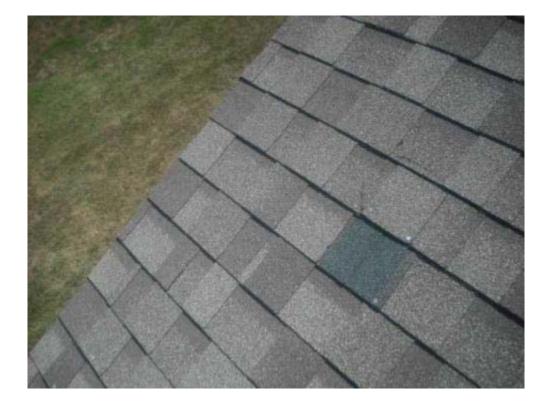
23

Overview of wind damage and temporary repair.

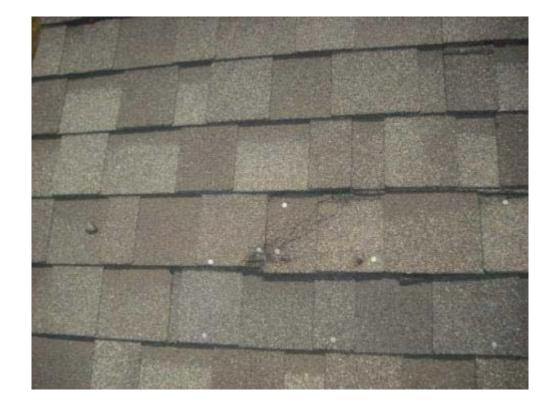
25

Overview of wind damage and temporary repair.

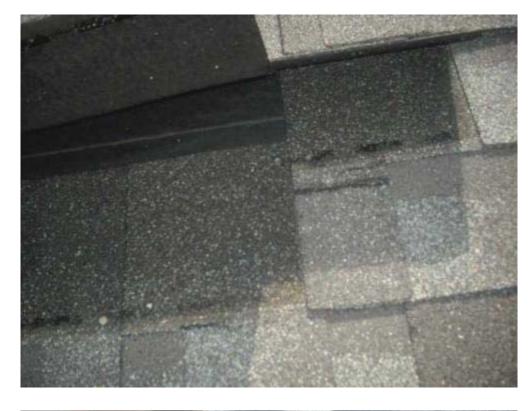
27

Overview of wind damage.

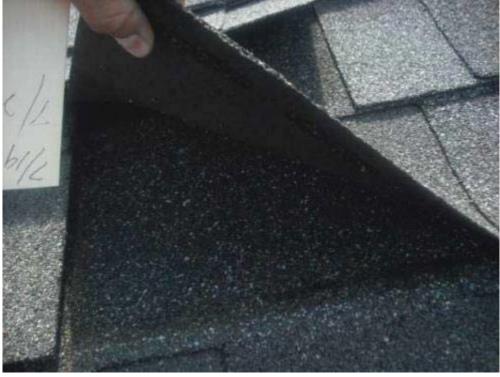
28

Date Taken: 4/20/2012 Taken By: CSI Representative Overview of wind damage.

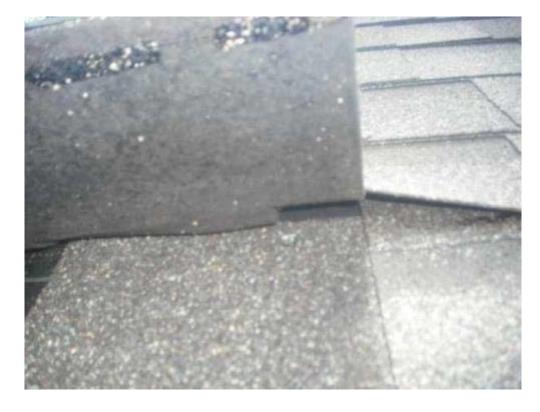
29

Overview of wind damage.

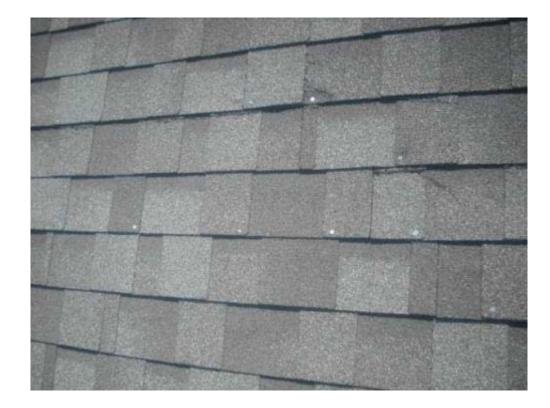
31

Overview of wind damage and temporary repair.

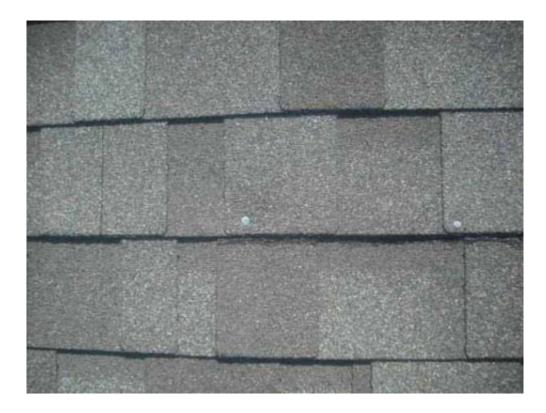
33

Overview of wind damage and temporary repair.

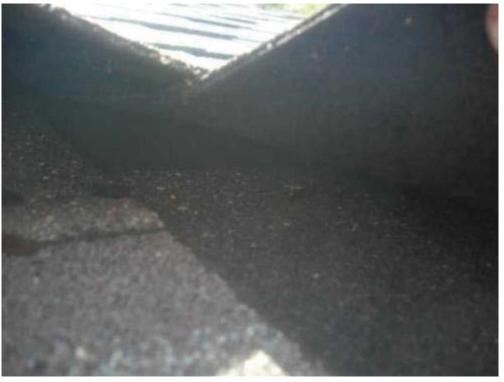
34

Date Taken: 4/20/2012 Taken By: CSI Representative Overview of wind damage.

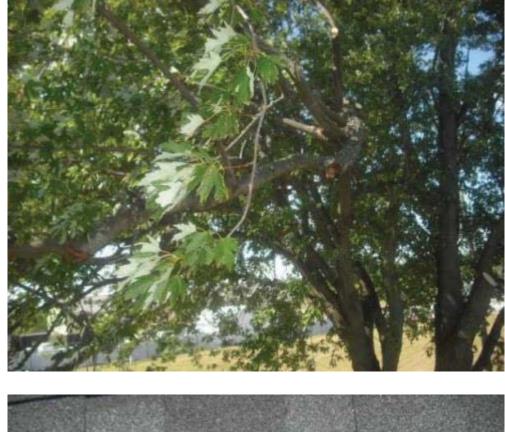
35

A small branch fell on the back slope.

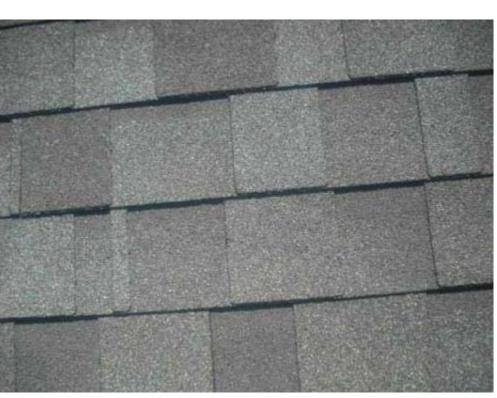
36

View of minor scarring from the tree branch.

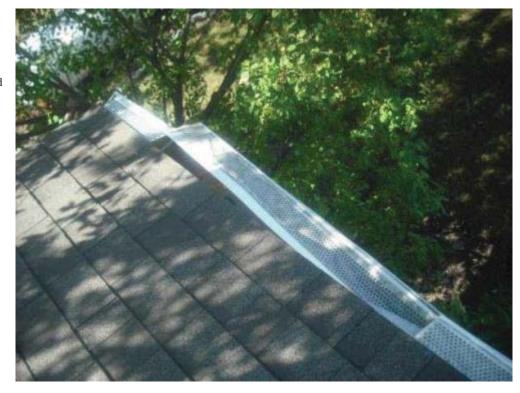
41

(2) **Exterior**: I inspected the exterior elevations and found tree damage to the gutter on the back elevation. There were no other exterior storm related damages.

View of tree damage to the gutter and screen.

DESCRIPTION	QUANTITY	UNIT COST	RCV	DEPREC.	ACV
R&R Gutter / downspout - aluminum - 6"	74.00 LF	8.05	595.70	(68.11)	527.59
R&R Gutter guard/screen	46.00 LF	2.77	127.42	(17.11)	110.31
Totals: Rear Elevation			723.12	85.22	637.90
Total: Exterior			723.12	85.22	637.90

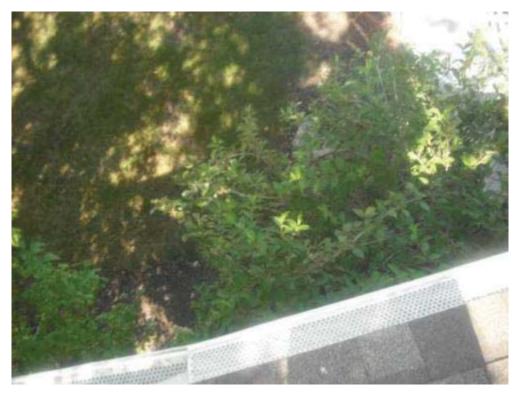
42

View of tree damage to the gutter and screen.

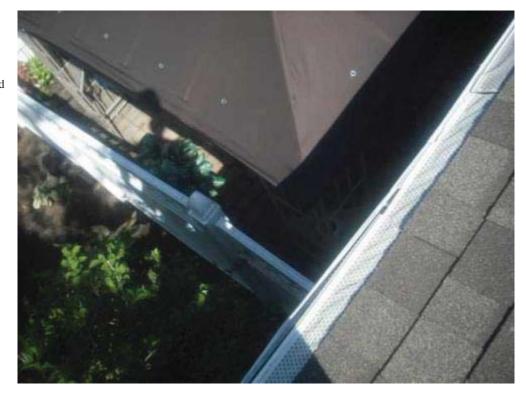
43

View of tree damage to the gutter and screen.

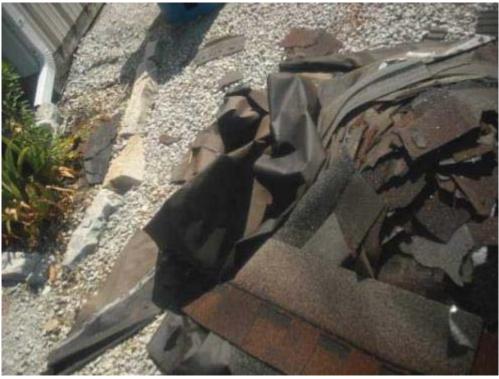
48

- (3) Interior: There was no interior inspection made as Mr. Barhorst stated that there were no interior damages.
- (4) Other Structures/APS: I inspected the other structures/APS and found damage to both slopes of the garage roof.
- (5) Contents: The canopy, flag pole and bird bath were damaged by the wind.

View of damaged shingles from the garage roof.

DESCRIPTION	QUANTITY	UNIT COST	RCV	DEPREC.	ACV		
Remove Laminated - comp. shingle rfg. - w/ felt	10.37 SQ	42.89	444.77	(0.00)	444.77		
Laminated - comp. shingle rfg w/ felt	11.67 SQ	183.57	2,142.26	(214.23)	1,928.03		
Drip edge	128.84 LF	1.35	173.93	(14.91)	159.02		
Roof vent - turtle type - Metal	3.00 EA	35.70	107.10	(9.18)	97.92		
Temporary Repair	1.00 EA	171.00	171.00	(0.00)	171.00		
ADDITIONAL LAYERS OF SHINGLES MUST BE VERIFIED TO BE CONSIDERED FOR A SUPPLEMENT,

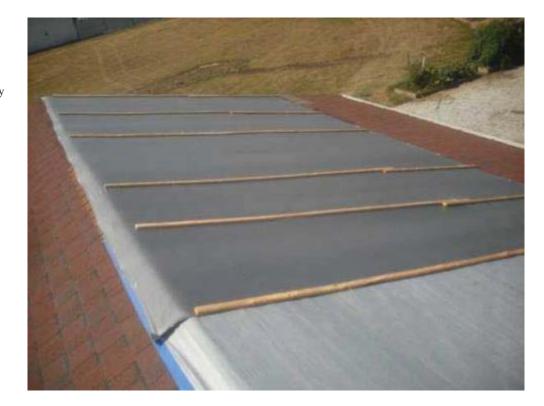
51

Back slope. Overview of temporary repair.

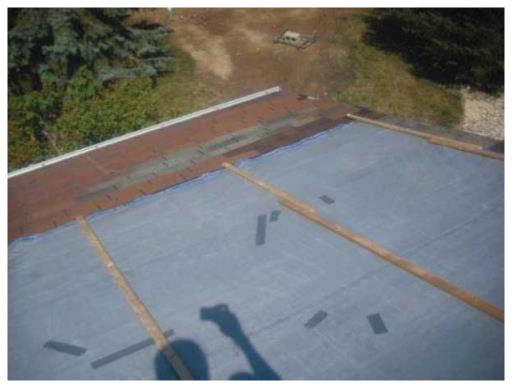
Back slope. Overview of temporary repair.

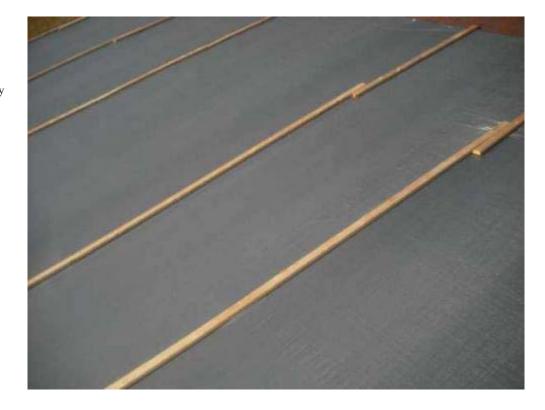
53

Back slope. Overview of temporary repair.

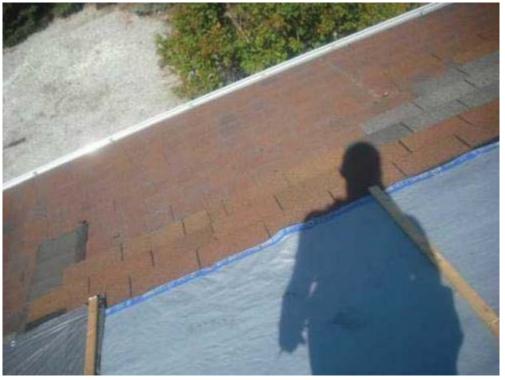
54

Back slope. Overview of temporary repair.

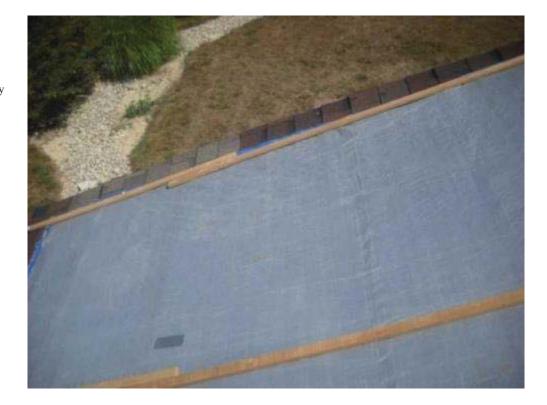
55

Back slope. Overview of temporary repair.

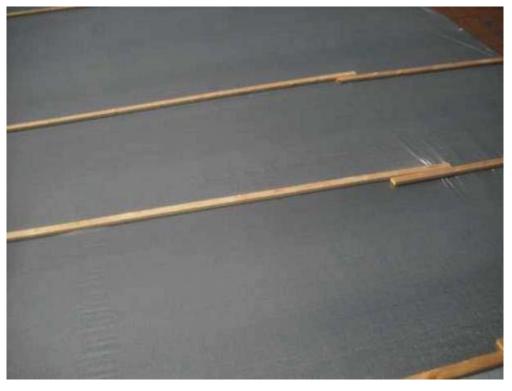
56

Back slope. Overview of temporary repair.

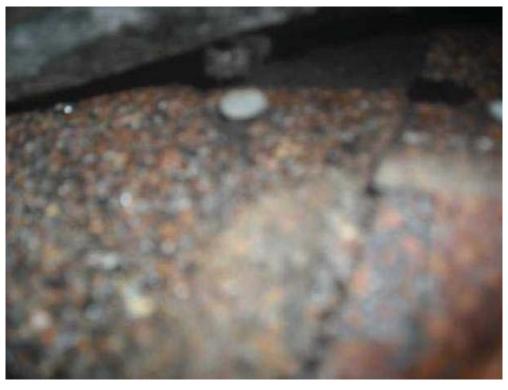
58

Some of the shingles on the front slope were uplifted and pulled through the nails.

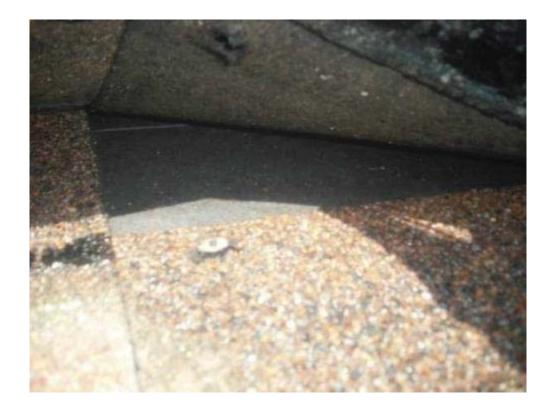
59

Some of the shingles on the front slope were uplifted and pulled through the nails.

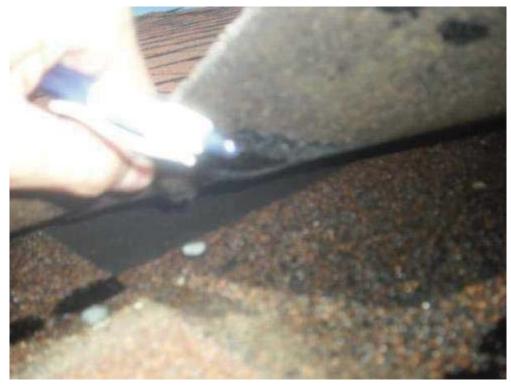
60

Some of the shingles on the front slope were uplifted and pulled through the nails.

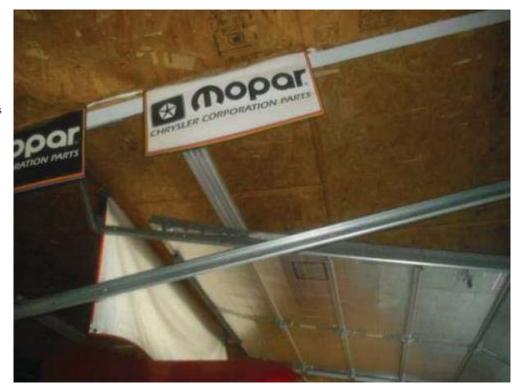
63

Rain water came in through the roof opeing and was pouring through the ceiling. The insulation in the attic was wet from the water.

DESCRIPTION	QUANTITY	UNIT COST	RCV	DEPREC.	ACV
Insulation - Minimum charge	1.00 EA	175.00	175.00	(0.00)	175.00
Totals: Interior			175.00	0.00	175.00
BARHOST				4/2/2013	Page: 3

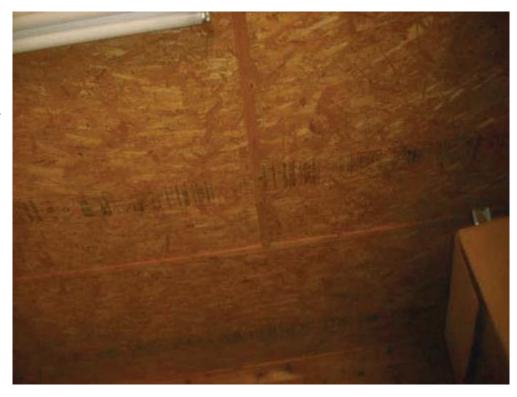
64

Rain water came in through the roof opeing and was pouring through the ceiling. The insulation in the attic was wet from the water.

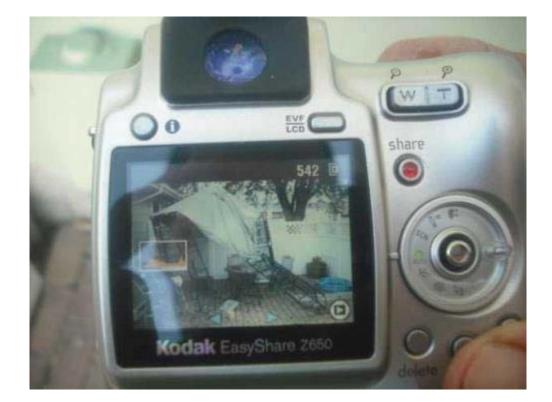
65

The canopy was damaged by the wind.

Contents				
DESCRIPTION	QUANTITY	UNIT COST	RCV	DEPREC.	ACV
Canopy	1.00 EA	278.18	278.18	(0.00)	278.18
Flag Pole	1.00 EA	85.00	85.00	(27.20)	57.80
Bird Bath	1.00 EA	159.45	159.45	(63.78)	95.67
Totals: Contents			522.63	90.98	431.65
Line Item Totals: BARHOS	Γ		12,575.65	2,205.40	10,370.25
Grand Total Areas:					
0.00 SF Walls	0.00	0.00 SF Ceiling		SF Walls and Ceiling	
0.00 SF Floor	0.00	0.00 SY Flooring		LF Floor Perimeter	
0.00 SF Long Wall	0.00	SF Short Wall	0.00	LF Ceil. Perimeter	
0.00 Floor Area	0.00	Total Area	0.00	Interior Wall Area	
1,691.13 Exterior Wall A	Area 0.00	Exterior Perimeter of Walls			
4,480.83 Surface Area	44.81	Number of Squares	475.40	Total Perimeter Len	gth
144.25 Total Ridge Le	ngth 0.00	Total Hip Length

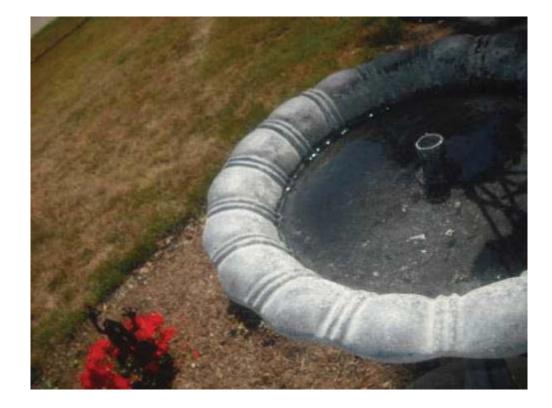
67

The bird bath blew over and was damaged.

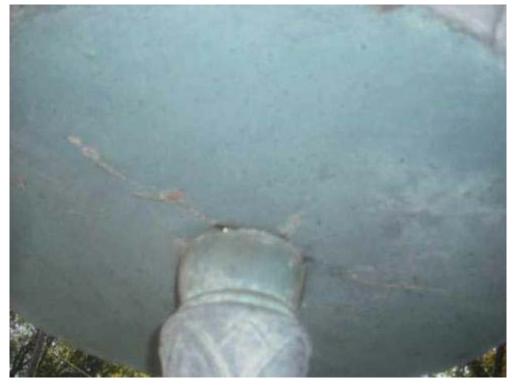
68

The bath cracked and was temporarily repaired by the insured.
