ABC Insurance 789 Smith Drive Dallas, TX 75231 PH: 456.555.1234 FX: 456.555.1235		LOSS REPORT Final		
Reference:	ABC Insurance 789 Smith Drive Dallas, TX 75231		Report #: 1 Catastrophe Number: Policy Number: 1234567890 Claim Number: 012-0004792-2012		
Insured:			Date of Loss: 6/29/2012		
	1234 Avenue D		Type of Loss: Wind Damage		
	Wapakoneta, OH 45895		File Number:		
ENCLOSU	RES:				
Estimate	, Statement of Loss, Diag	grams			
COVERAG	E:				
Loc	1 Bldg 1 2 Bldg 1 elling	\$412,400.00 \$294,600.00 \$0.00	Mortgagee: none Deductible: \$2,000.00 Co-Ins. Policy: Yes 🗌 No 🗖		
Oth	er Structures	\$0.00	Forms:

FINAL REPORT

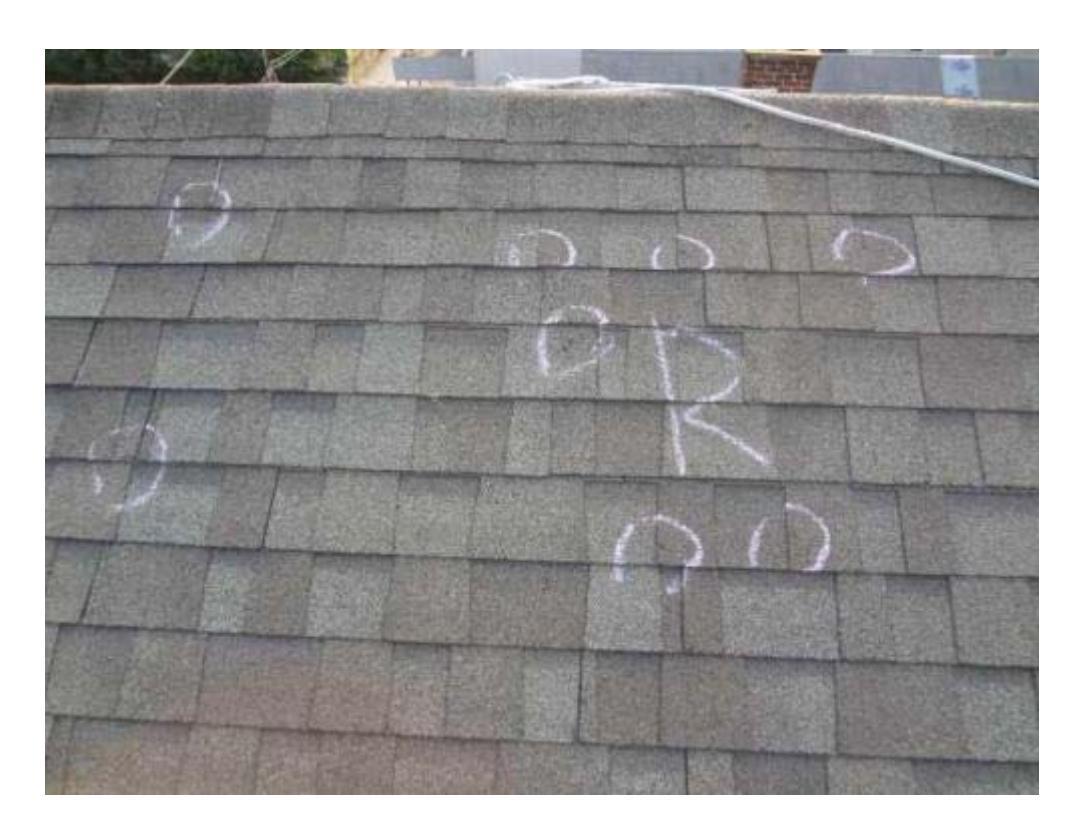
5 Loc 1 Front Slope Date Taken: 7/15/2012 Taken By: CSI Representative

(1) Loc 1 Bldg 1 Roof: I began my inspection with the roof. The 3 story tall 16 year old roof had a section with 30 year shingles, a section with 20 year 3-tab shingles and the rest of the roof was aluminum with a coating over it. There was hail and wind damage to the shingled roof sections and they have been figured for replacement. The aluminum roof coating was damaged by the hail as well.

Overview of hail damage.

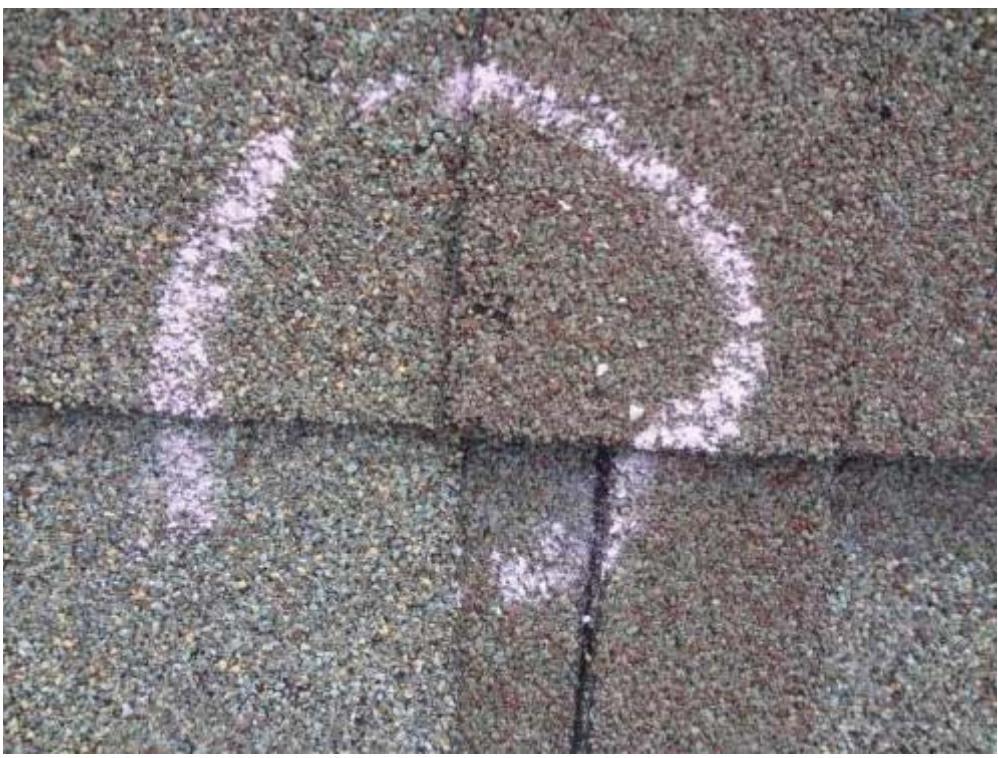
7 Loc 1 Front SlopeDate Taken: 7/15/2012Taken By: CSI Representative

View of a hail impact mark.

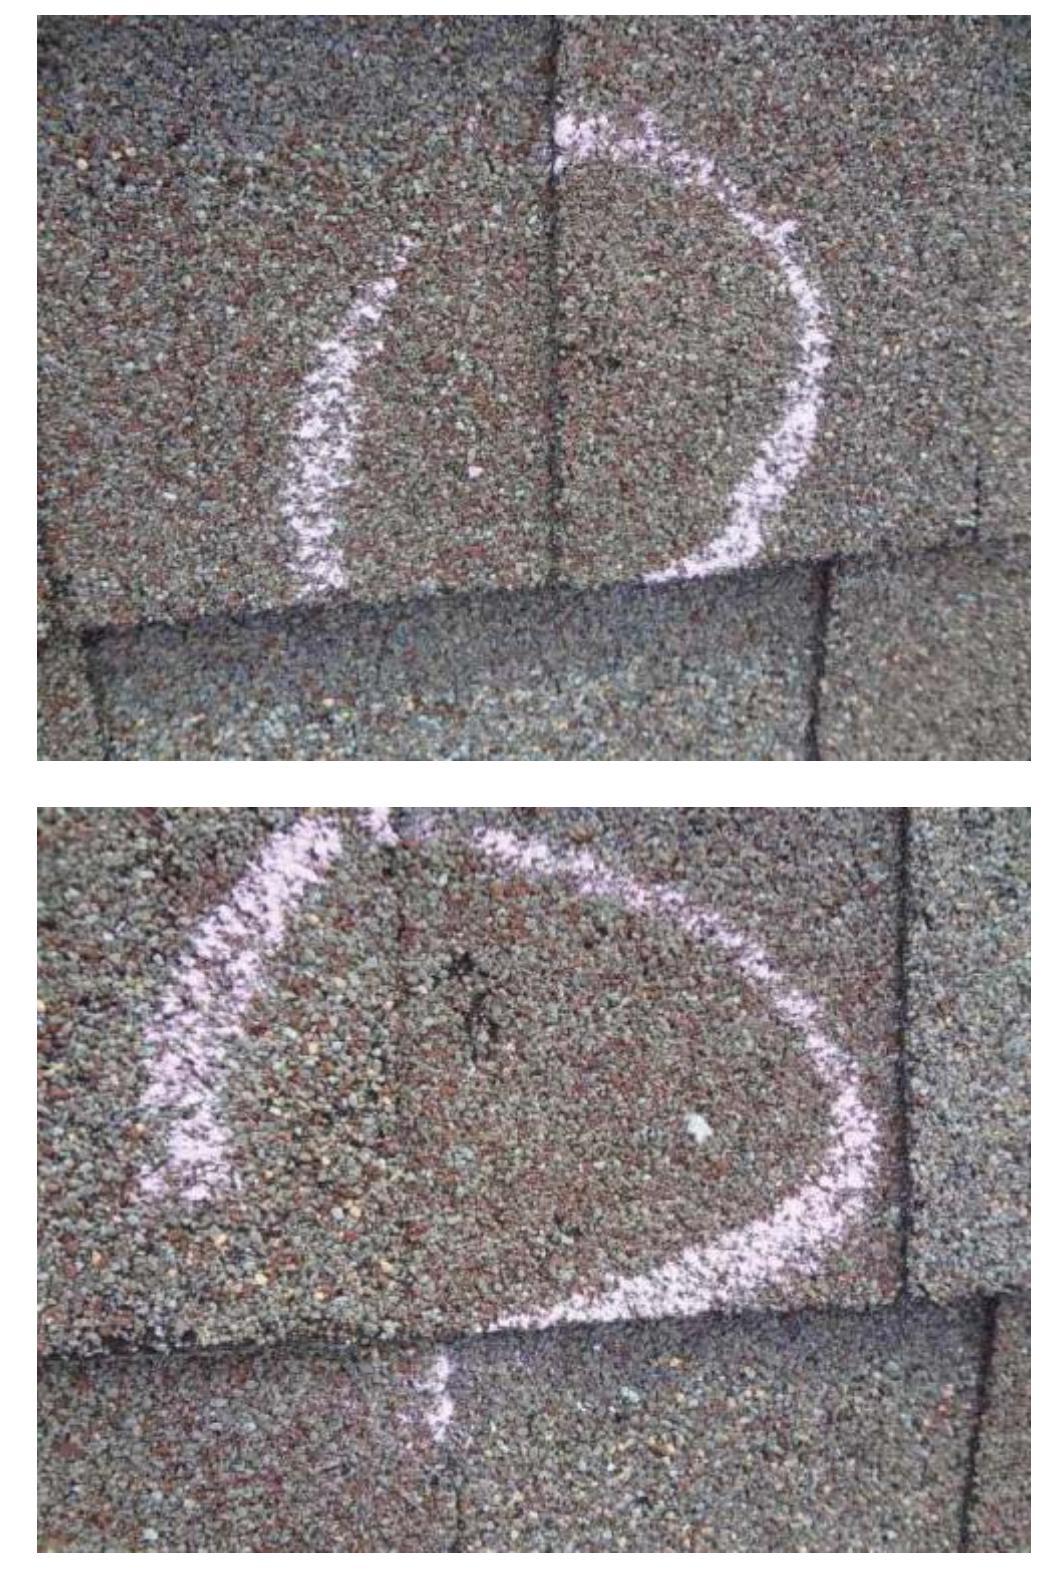
9 Loc 1 Front SlopeDate Taken: 7/15/2012Taken By: CSI Representative

View of a hail impact mark.

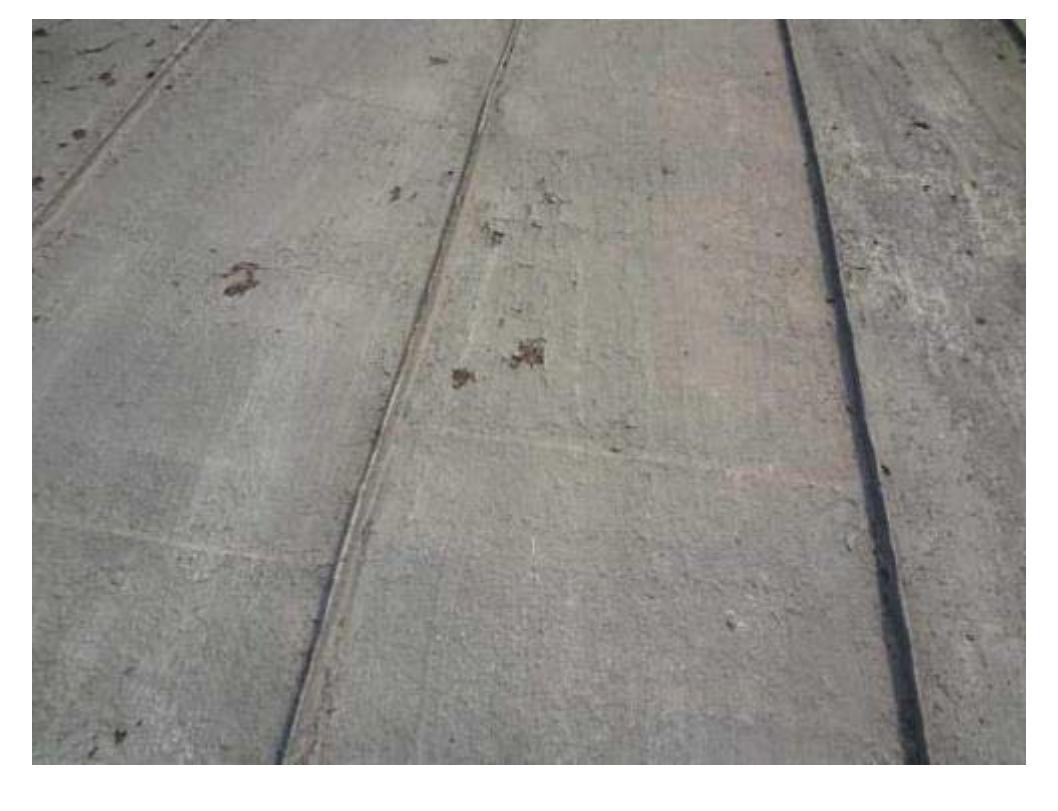
11 Loc 1 Right SlopeDate Taken: 7/15/2012Taken By: CSI Representative

View of hail damage to the roof coat.

6. Aluminum coating - without fiber	5,110.00 SF	0.44	2,248.40	<1,606.00>	642.40
7. Drip edge	281.00 LF	1.32	370.92	<169.56>	201.36
8. Remove Additional charge for high roof (2 stories or greater)	92.37 SQ	4.15	383.34	(0.00)	383.34

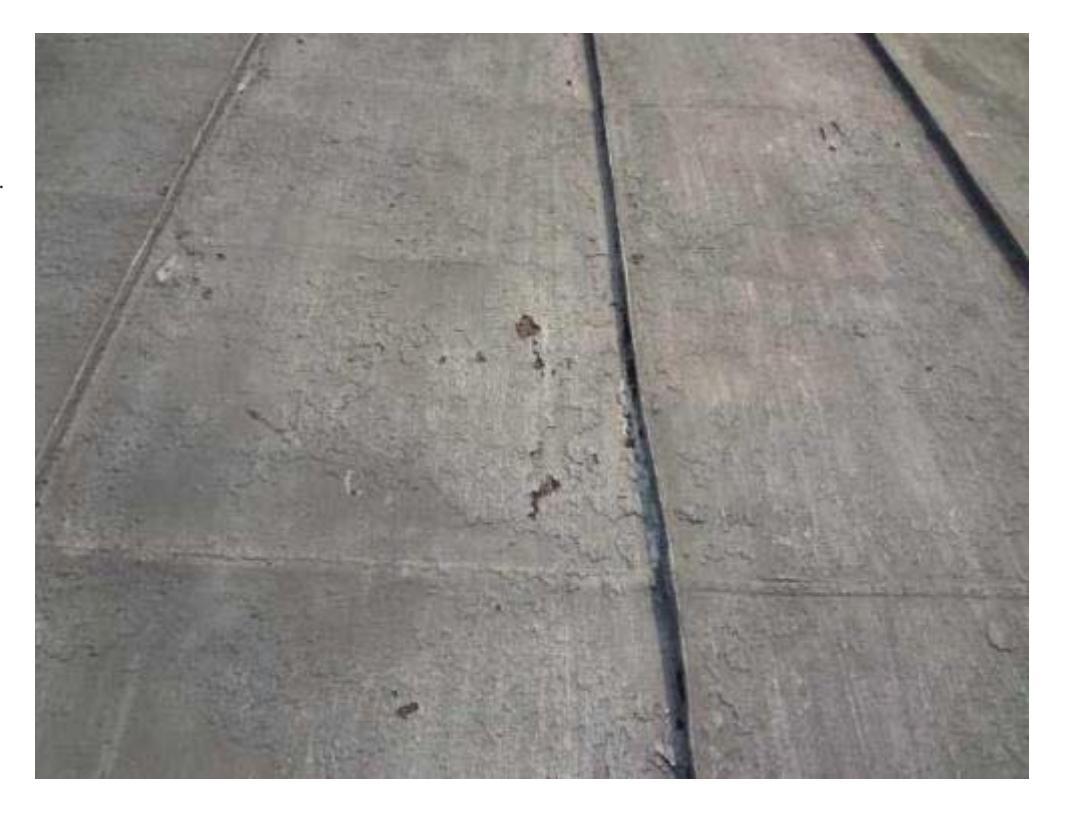
13 Loc 1 Back Slope Date Taken: 7/15/2012 Taken By: CSI Representative

View of hail damage to the roof coat.

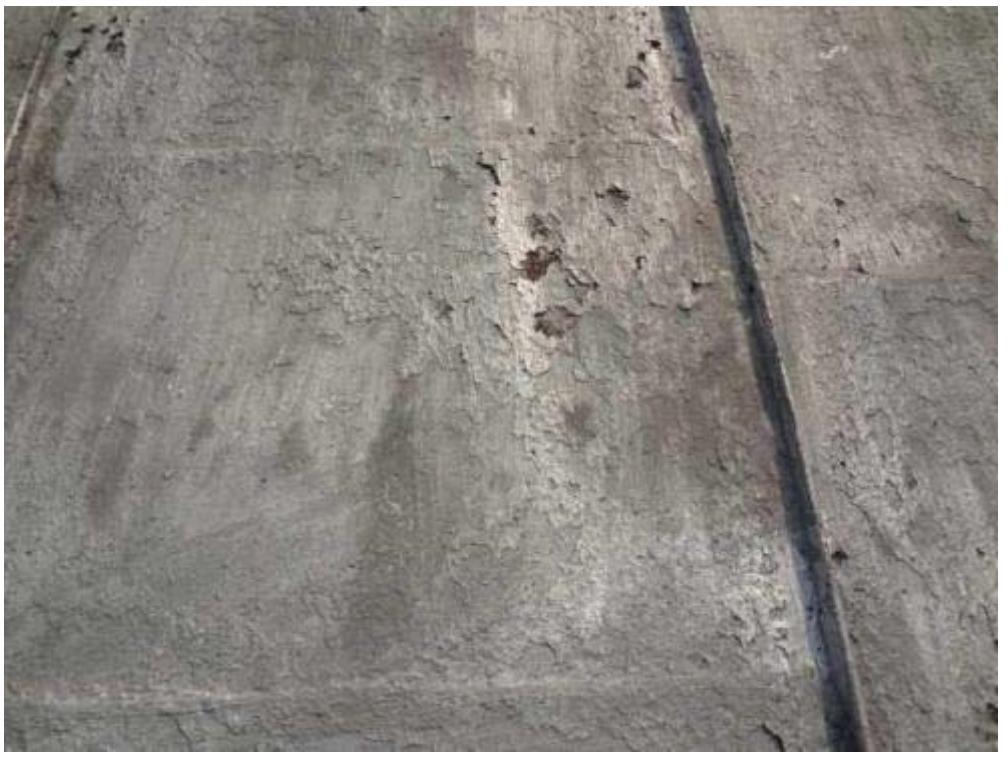
Loc 1 Back Slope
 Date Taken: 7/15/2012
 Taken By: CSI Representative
 View of hail damage to the roof coat.

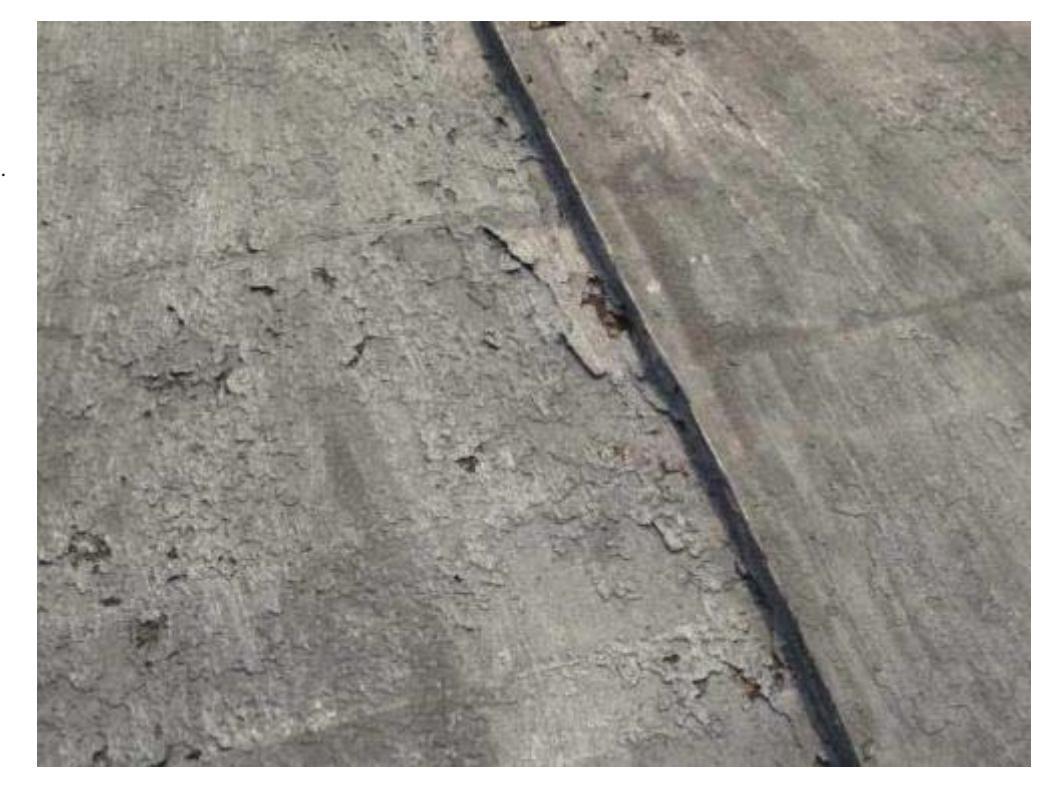
15 Loc 1 Back Slope Date Taken: 7/15/2012 Taken By: CSI Representative

View of hail damage to the roof coat.

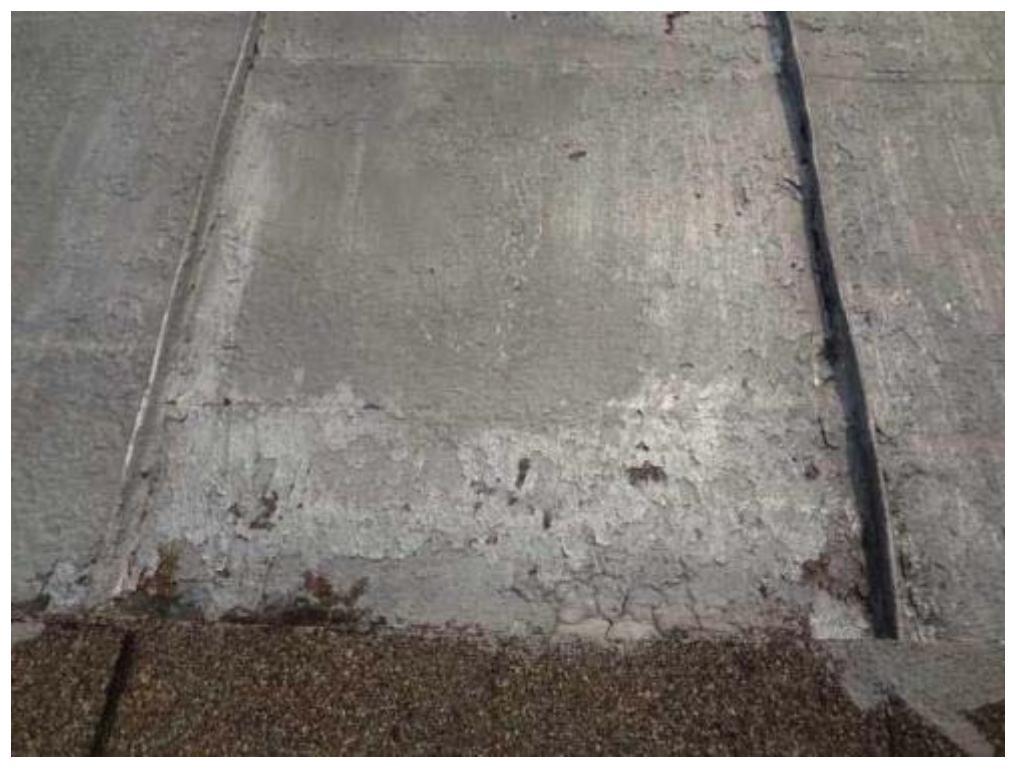
Loc 1 Back Slope
 Date Taken: 7/15/2012
 Taken By: CSI Representative
 View of hail damage to the roof coat.

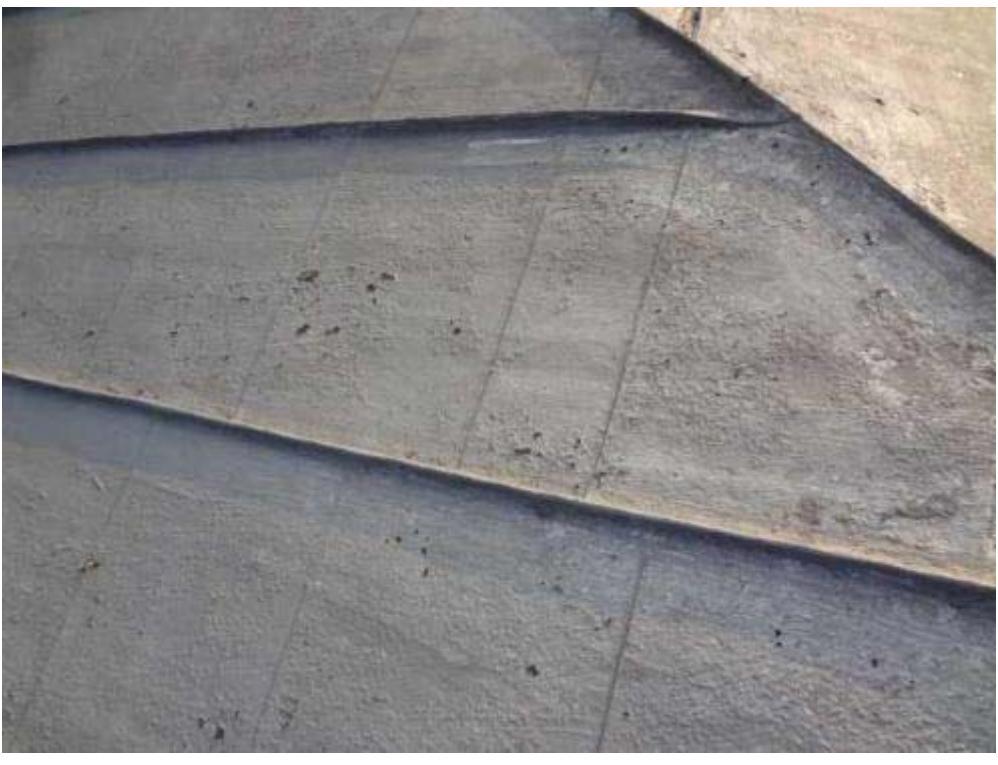
Loc 1 Left Slope
 Date Taken: 7/15/2012
 Taken By: CSI Representative
 View of hail damage to the roof coat.

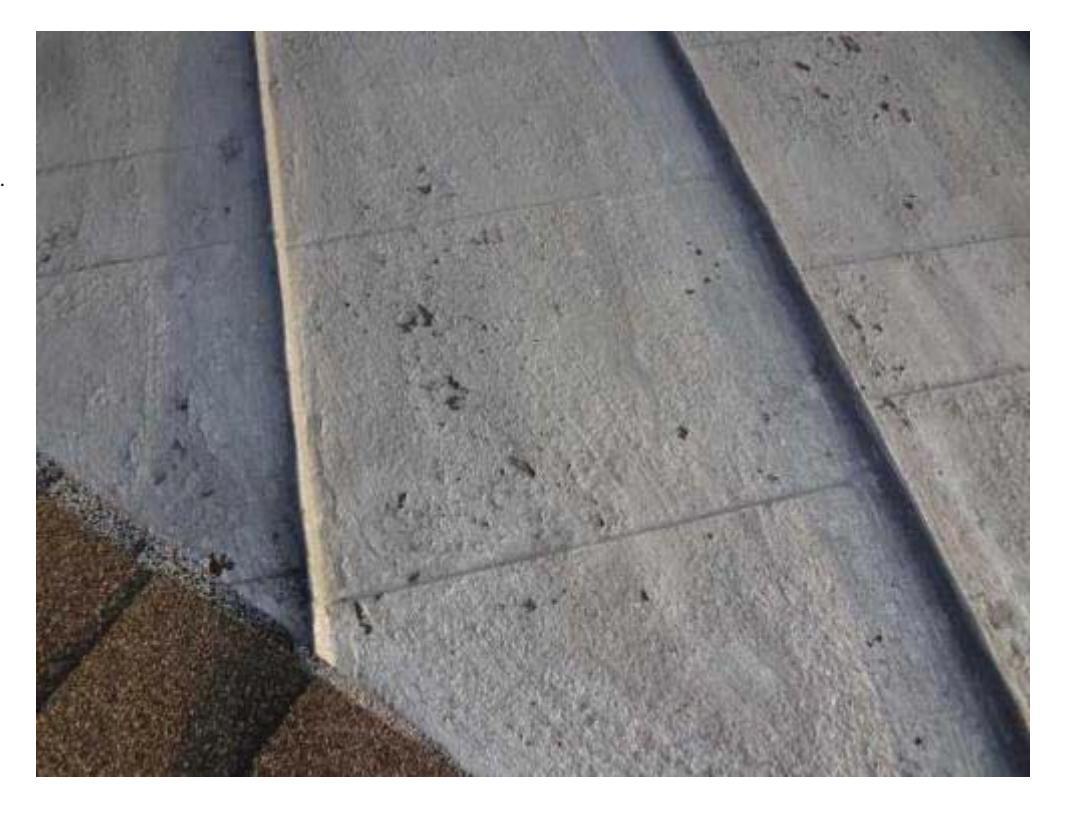
19 Loc 1 Left Slope Date Taken: 7/15/2012 Taken By: CSI Representative

View of hail damage to the roof coat.

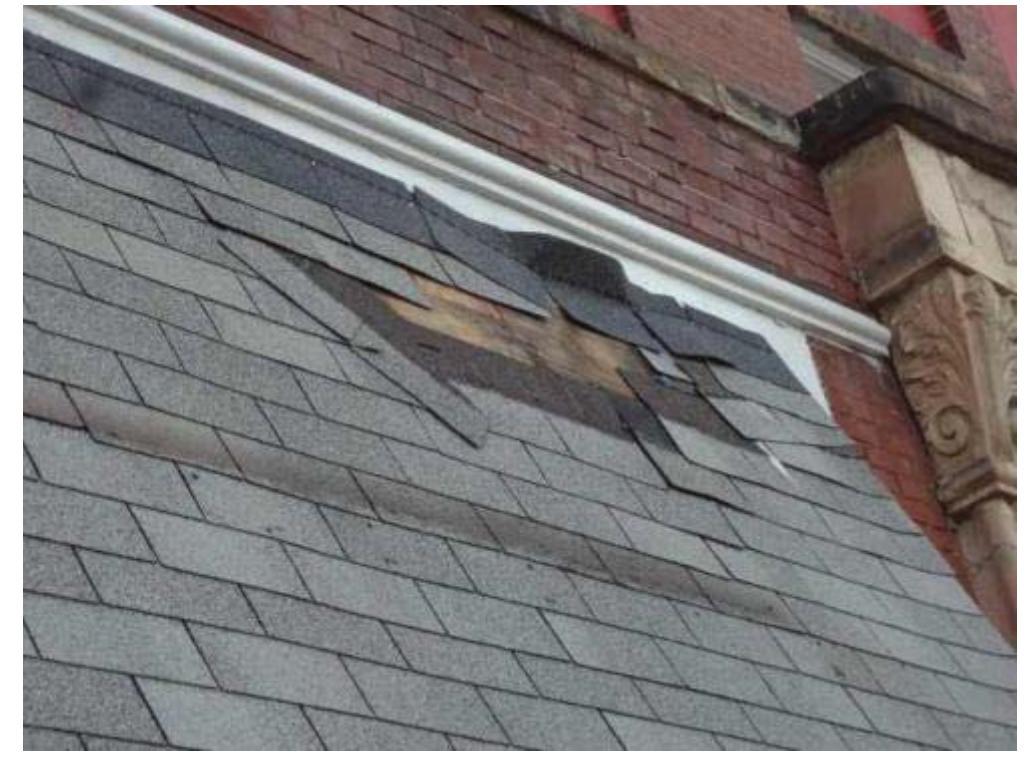
20 Loc 1 Lower Roof Date Taken: 7/15/2012 Taken By: CSI Representative View of wind damage.

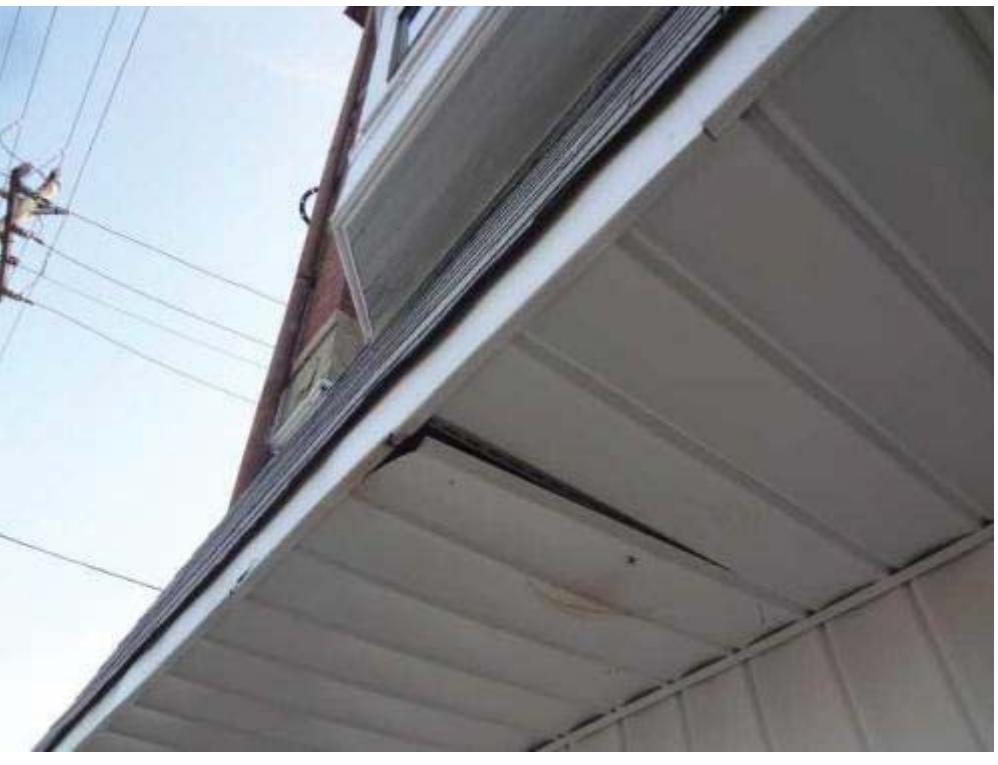
(2) Loc 1 Bldg 1 Exterior: On the front elevation I found storm damage to the vinyl fascia and soffit. I inspected the remaining exterior elevations and found no storm related damage at the time of inspection.

22 Loc 1 Front Elev Date Taken: 7/15/2012 Taken By: CSI Representative View of wind damage to the soffit.

Loc 1 I	Front Elevation				
DESCRIPTION	QUANTITY	UNIT COST	RCV	DEPREC.	ACV
13. Soffit, fascia & gutter - Minimum chargeAllows for soffit and fascia.	1.00 EA	230.00	230.00	(0.00)	230.00
Totals: Loc 1 Front Elevation			230.00	0.00	230.00
M&G-TRIPLETT				4/2/2013	Page: 2

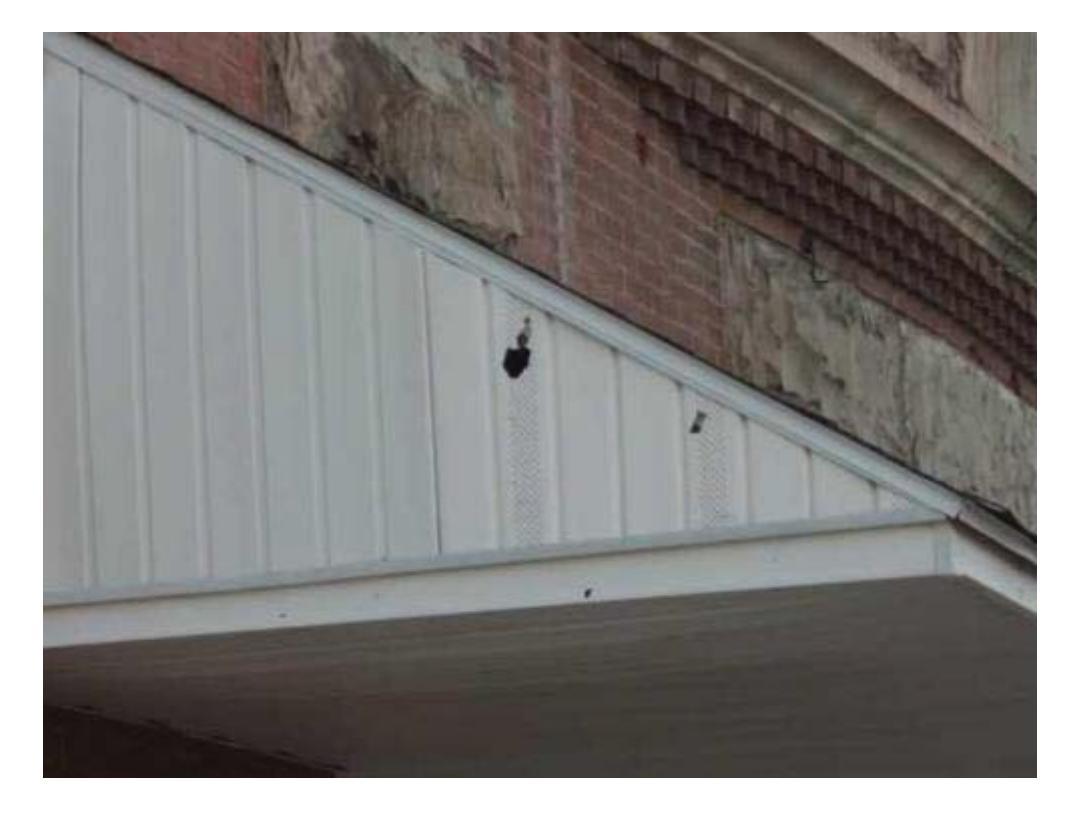
23 Loc 1 Front Elev Date Taken: 7/15/2012 Taken By: CSI Representative

View of damage to the fascia.

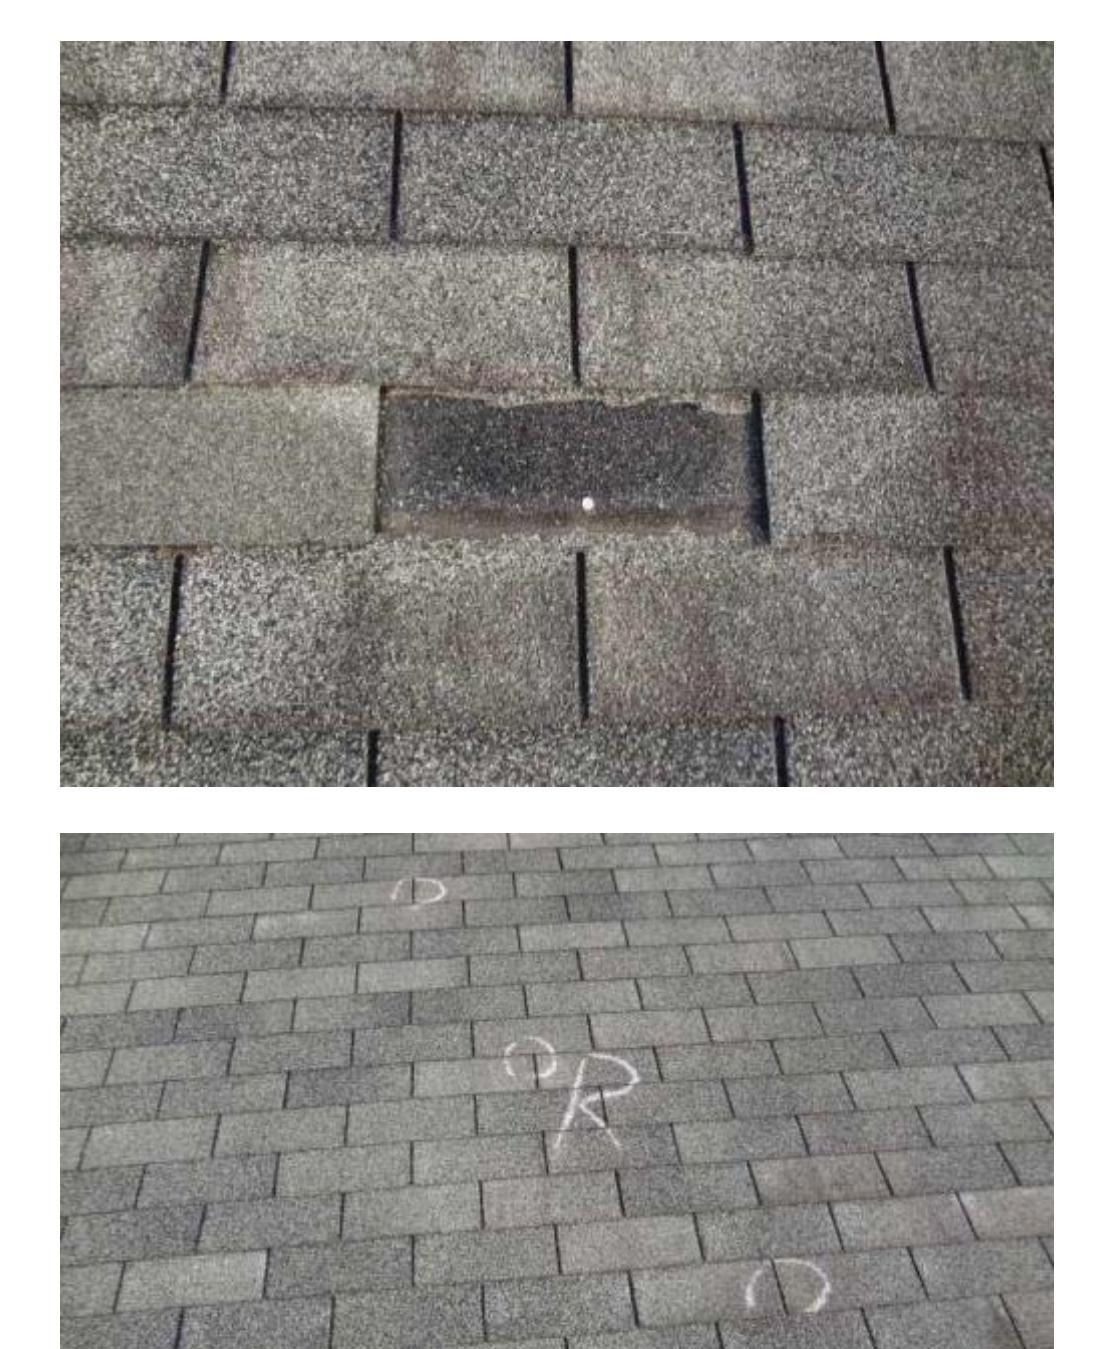
39 Loc 2 Right SlopeDate Taken: 7/15/2012Taken By: CSI Representative

View of wind damage.

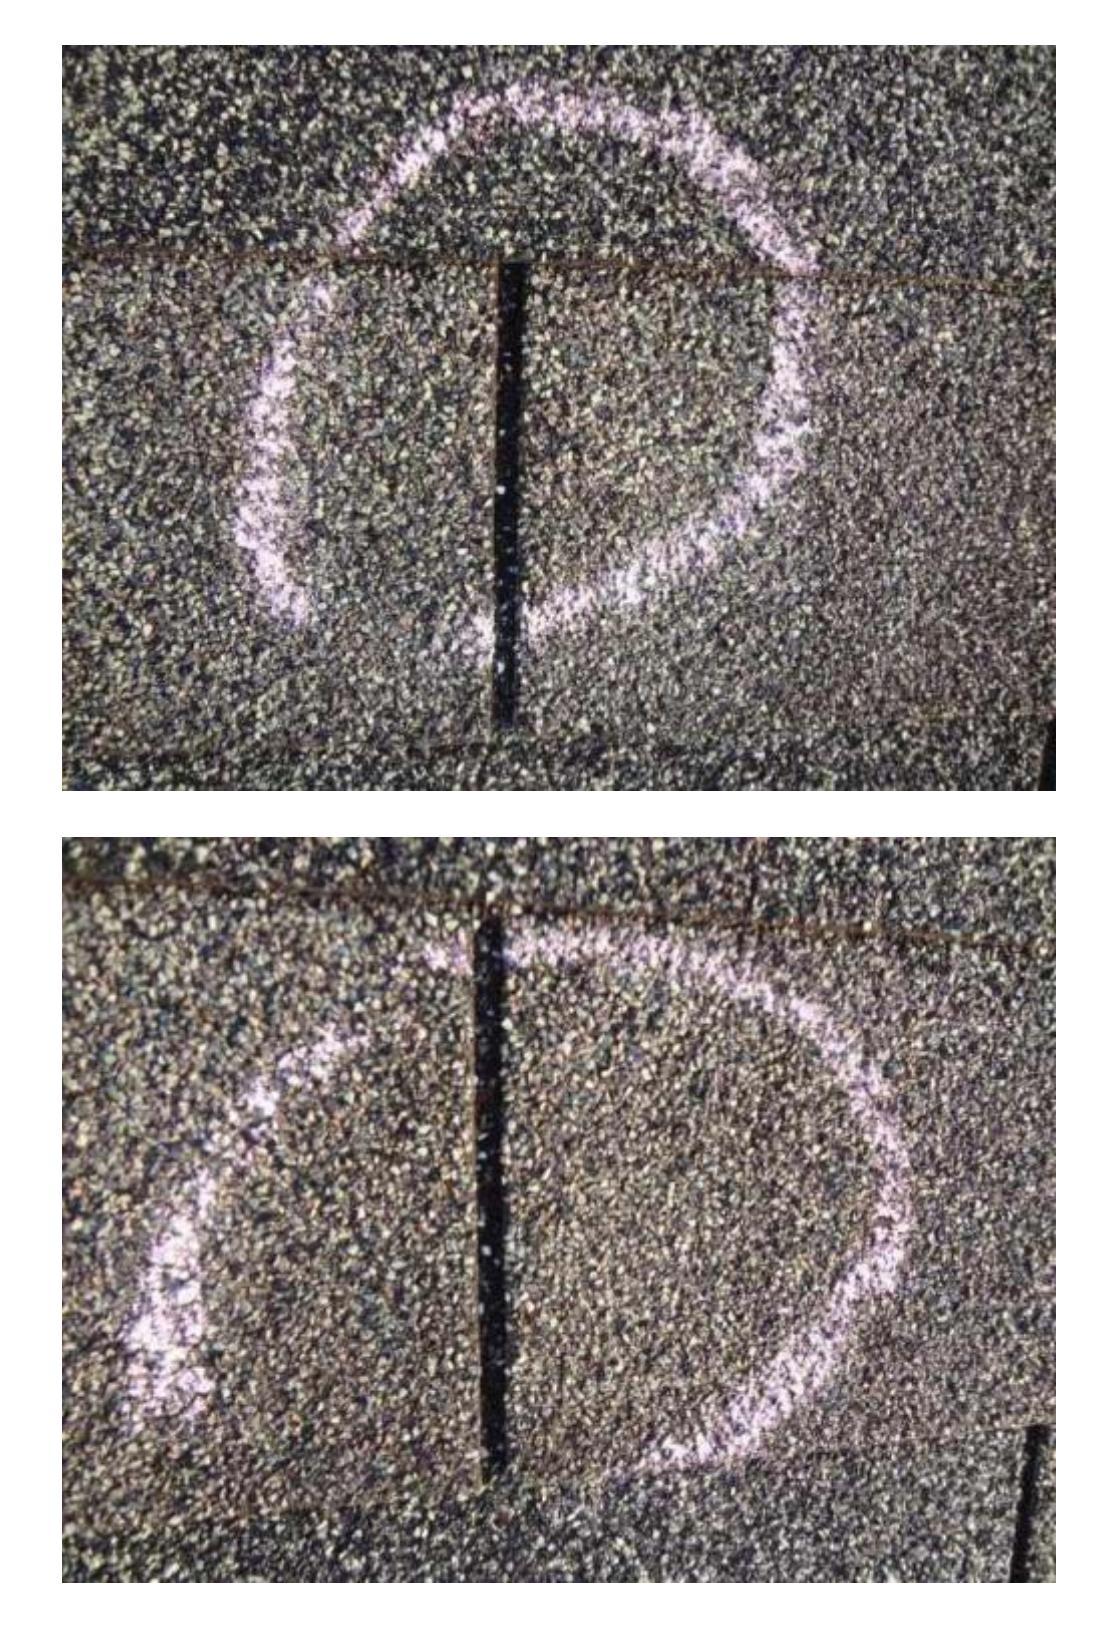
41 Loc 2 Right Slope Date Taken: 7/15/2012 Taken By: CSI Representative

View of a hail impact mark.

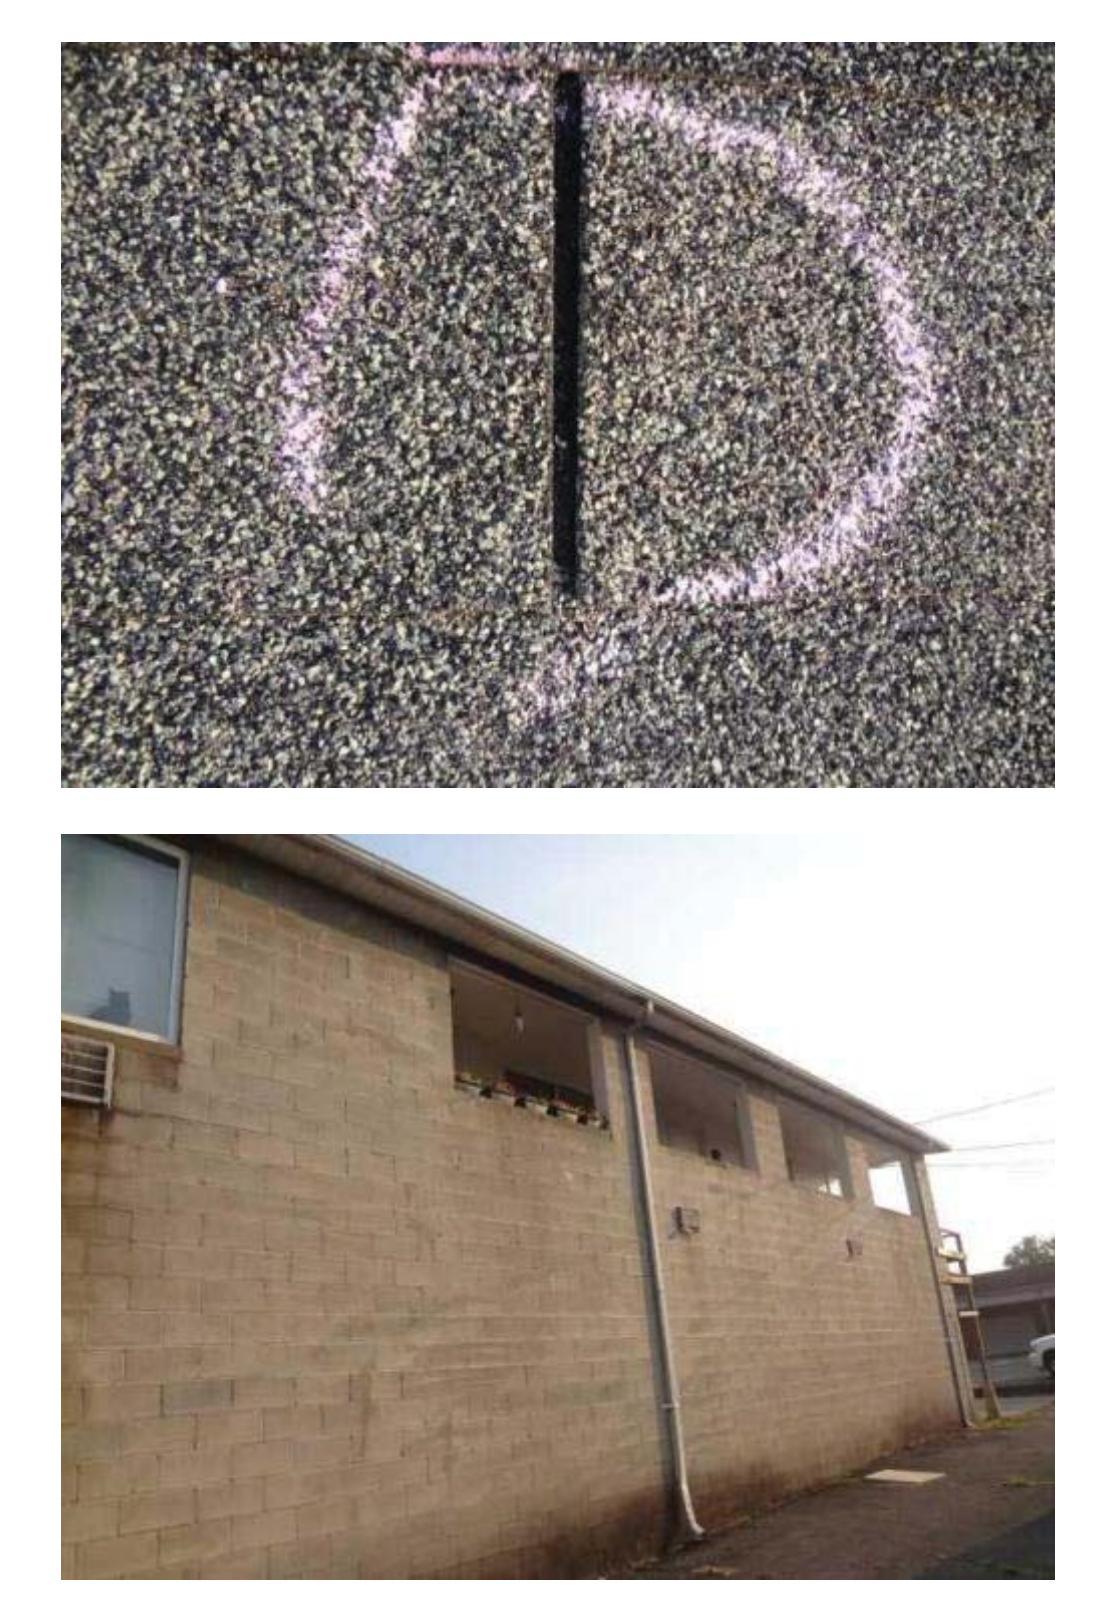
42 Loc 2 Right Slope Date Taken: 7/15/2012 Taken By: CSI Representative

View of a hail impact mark.

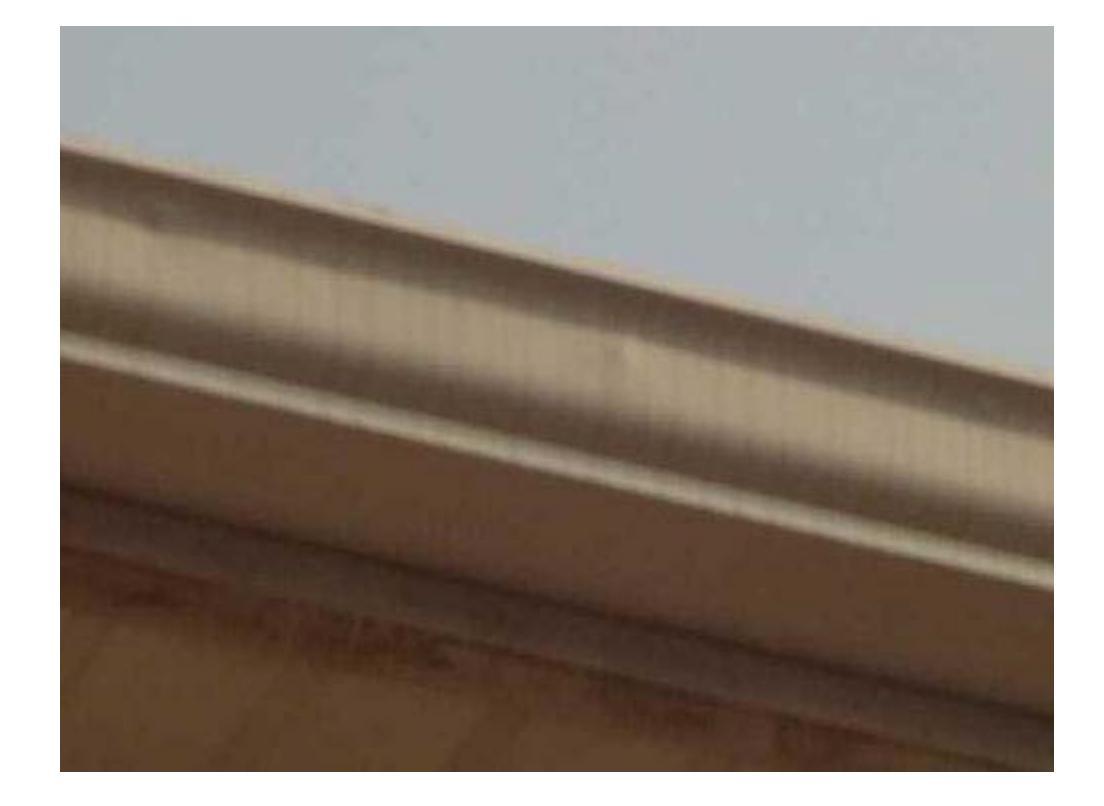
45 Loc 2 Right ElevDate Taken: 7/15/2012Taken By: CSI Representative

View of damage to the gutter.

DESCRIPTION	QUANTITY	UNIT COST	RCV	DEPREC.	ACV
21. R&R Gutter / downspout - aluminum - 6"	122.00 LF	8.38	1,022.36	<623.86>	398.50
Totals: Loc 2 Right			1,022.36	623.86	398.50

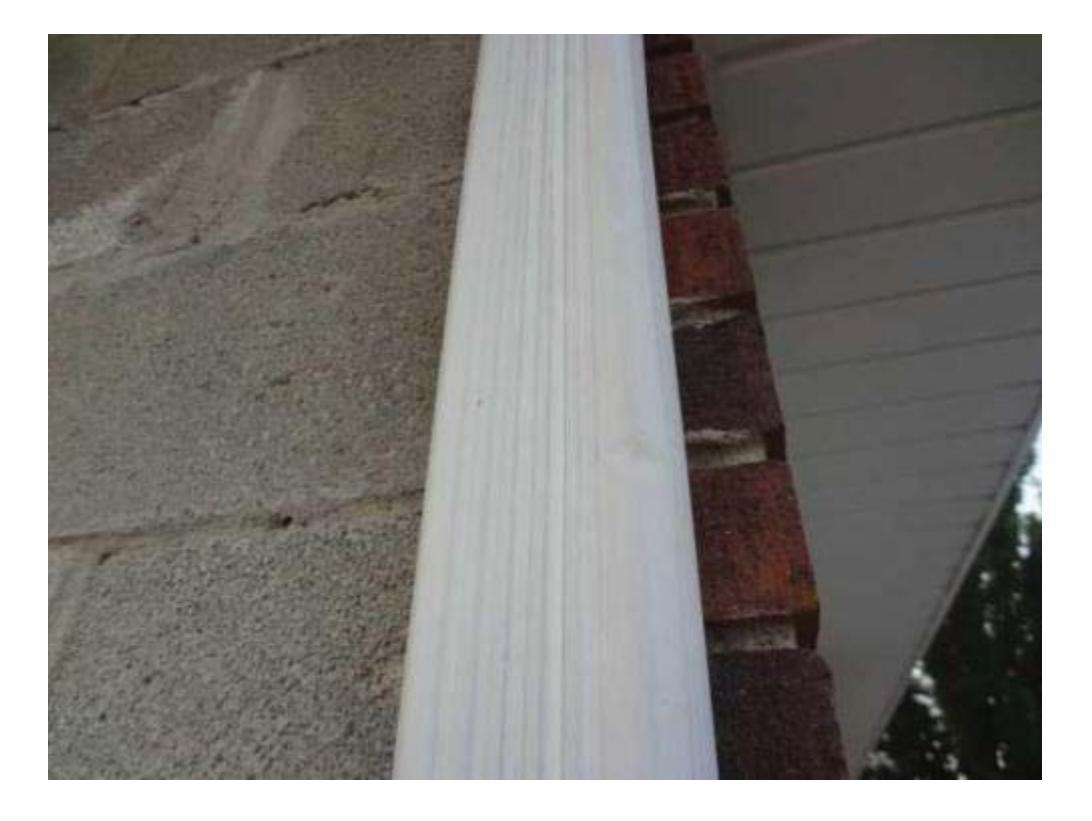
48 Loc 2 Back Elevation Date Taken: 7/15/2012 Taken By: CSI Representative

View of damage to the downspout.

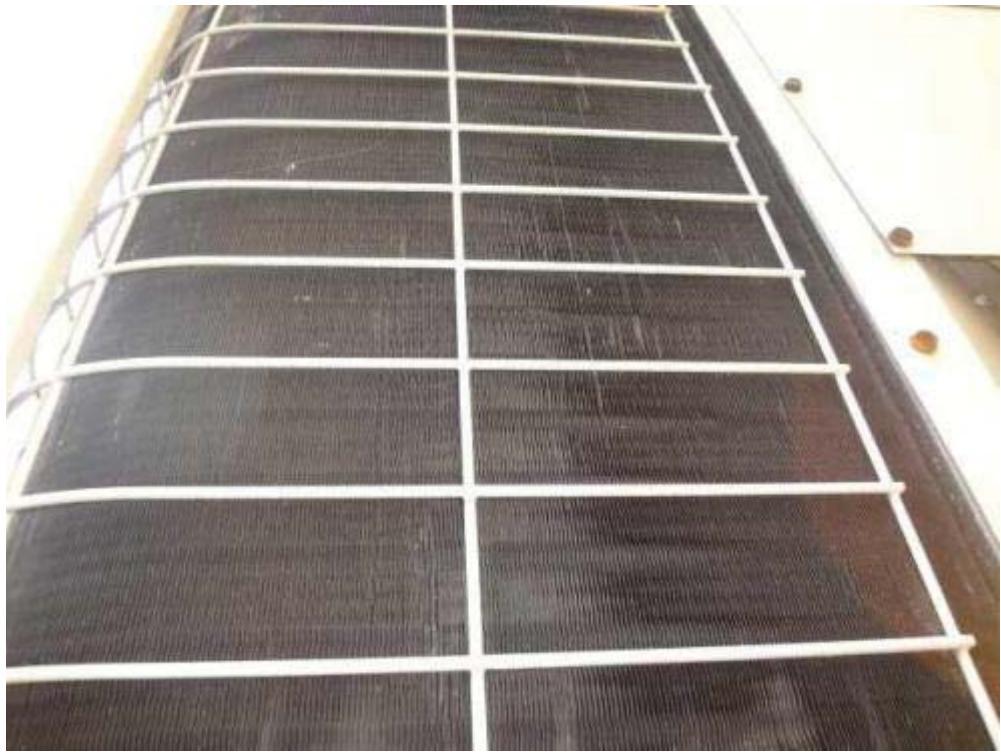
50 Loc 2 Left Elevation Date Taken: 7/15/2012 Taken By: CSI Representative View of damage to the HVAC fins.

Loc 2 E	Back				
DESCRIPTION	QUANTITY	UNIT COST	RCV	DEPREC.	ACV
23. Comb and straighten a/c condenser fins - with trip charge	1.00 EA	119.76	119.76	(0.00)	119.76
24. Siding - Minimum charge	1.00 EA	230.00	230.00	(0.00)	230.00
Totals: Loc 2 Back			349.76	0.00	349.76
Total: Main Level			10,555.49	4,993.38	5,562.11
Total: SKETCH2			10,555.49	4,993.38	5,562.11
Line Item Totals: M&G-TRIPLETT			25,967.40	11,860.90	14,106.50

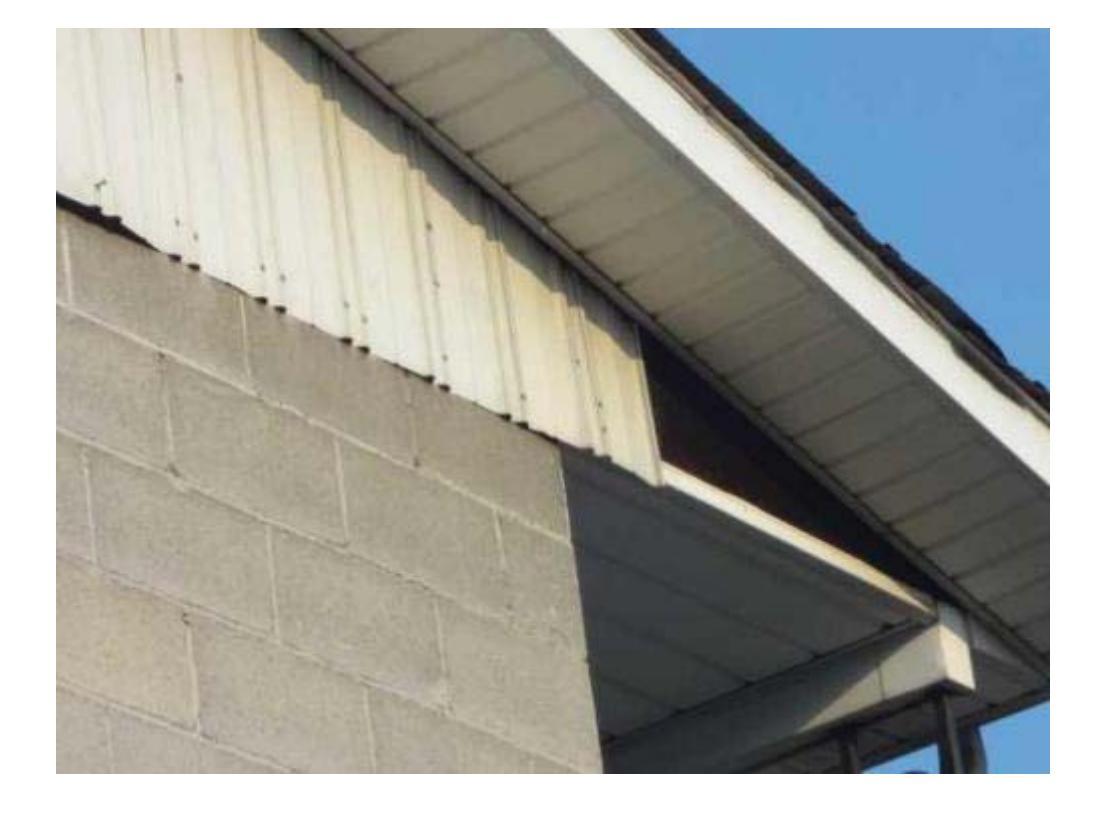
51 Loc 2 Left Elevation Date Taken: 7/15/2012 Taken By: CSI Representative

View of damage to the siding.
