ABC Insurance 789 Smith Drive Dallas, TX 75231 PH: 456.555.1234 FX: 456.555.1235		LOSS REPORT Final		
Reference:	ABC Insurance 789 Smith Drive Dallas, TX 75231		Report #: 1 Catastrophe Number: Policy Number: 1234567890 Claim Number: 012-0004792-2012		
Insured:			Date of Loss: 6/29/2012		
	1234 Avenue D		Type of Loss: Wind Damage		
	Wapakoneta, OH 45895		File Number:		
ENCLOSU	RES:				
Estimate	, Statement of Loss, Diag	grams			
COVERAG	E:				
Loc	1 Bldg 1 2 Bldg 1 elling	\$412,400.00 \$294,600.00 \$0.00	Mortgagee: none Deductible: \$2,000.00 Co-Ins. Policy: Yes 🗌 No 🗖		
Oth	er Structures	\$0.00	Forms:

FINAL REPORT

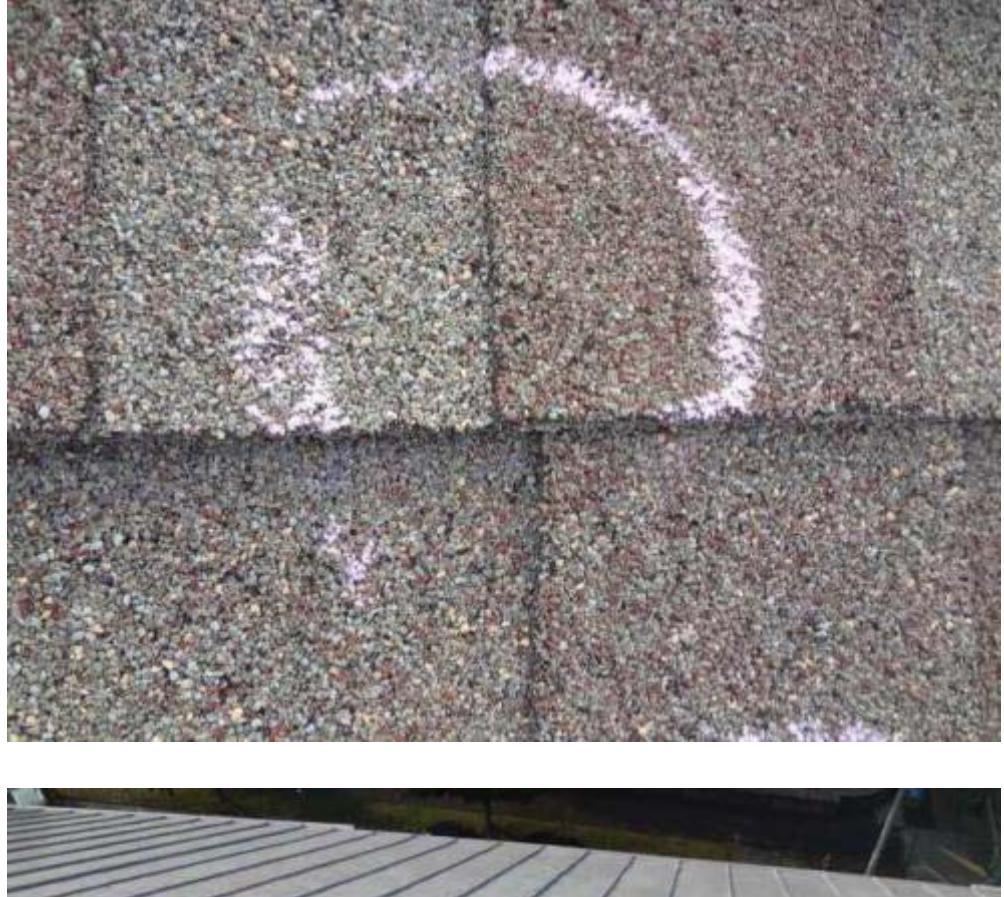
View of a hail impact mark.

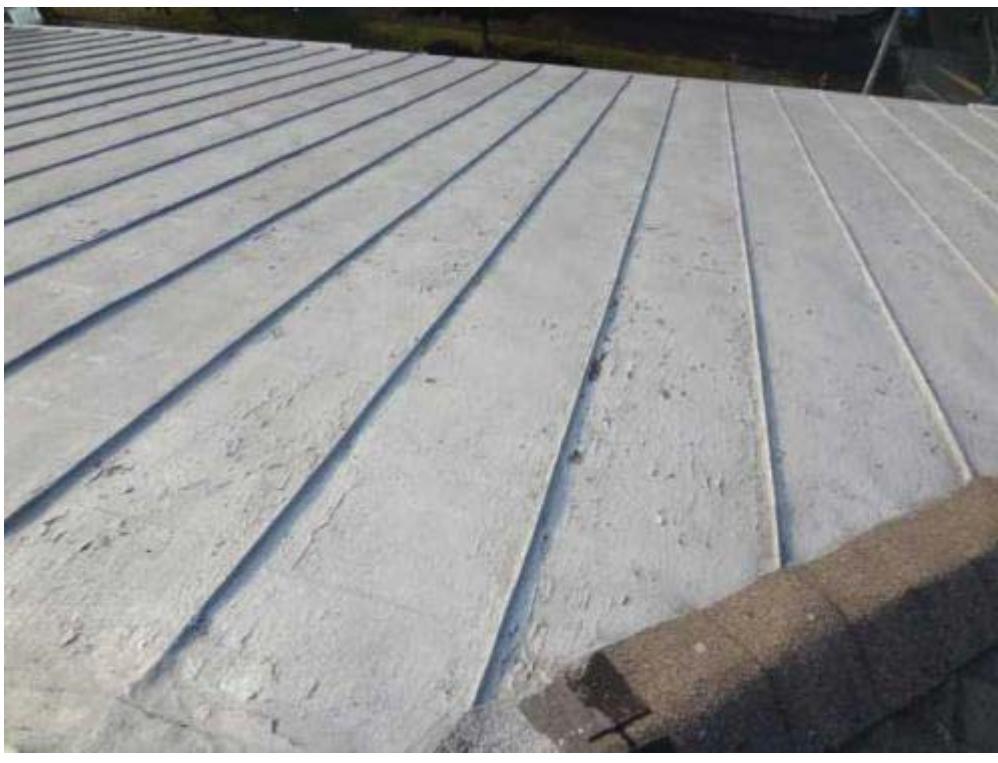
(1) Loc 1 Bldg 1 Roof: I began my inspection with the roof. The 3 story tall 16 year old roof had a section with 30 year shingles, a section with 20 year 3-tab shingles and the rest of the roof was aluminum with a coating over it. There was hail and wind damage to the shingled roof sections and they have been figured for replacement. The aluminum roof coating was damaged by the hail as well.

Slope overview.

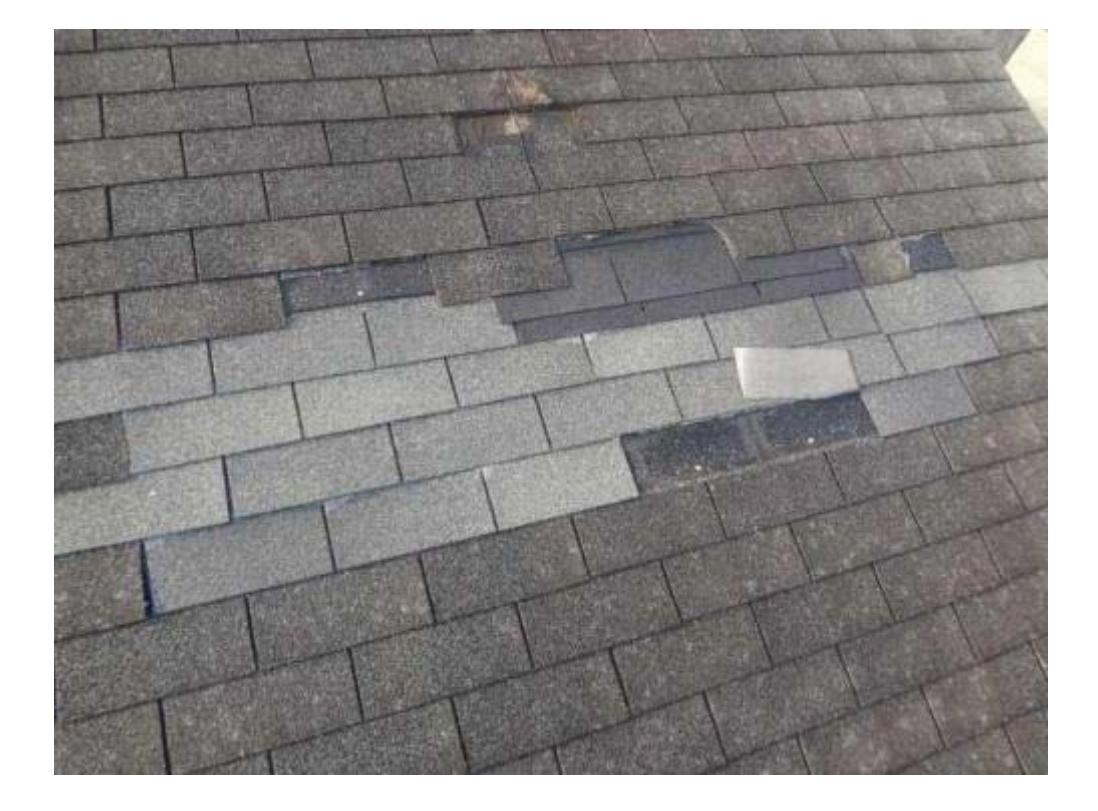
31 Loc 2 Left Slope

View of shingles that were temporarily installed to prevent further damage.

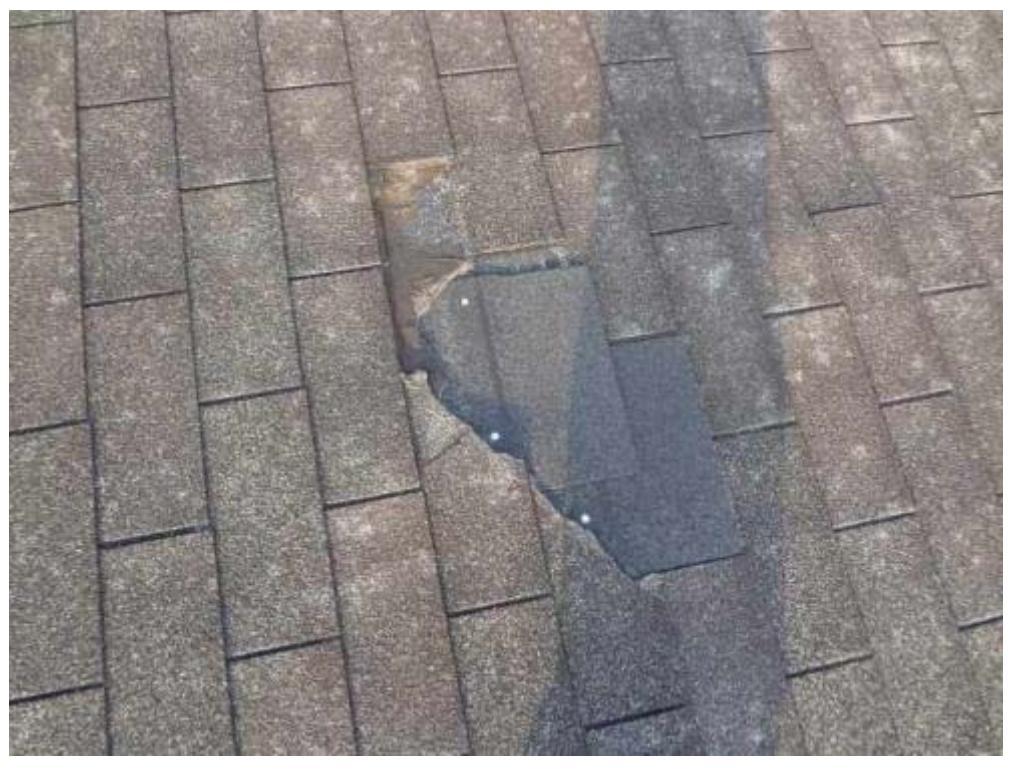
32 Loc 2 Left Slope Date Taken: 7/15/2012 Taken By: CSI Representative

> View of shingles that were temporarily installed to prevent further damage.

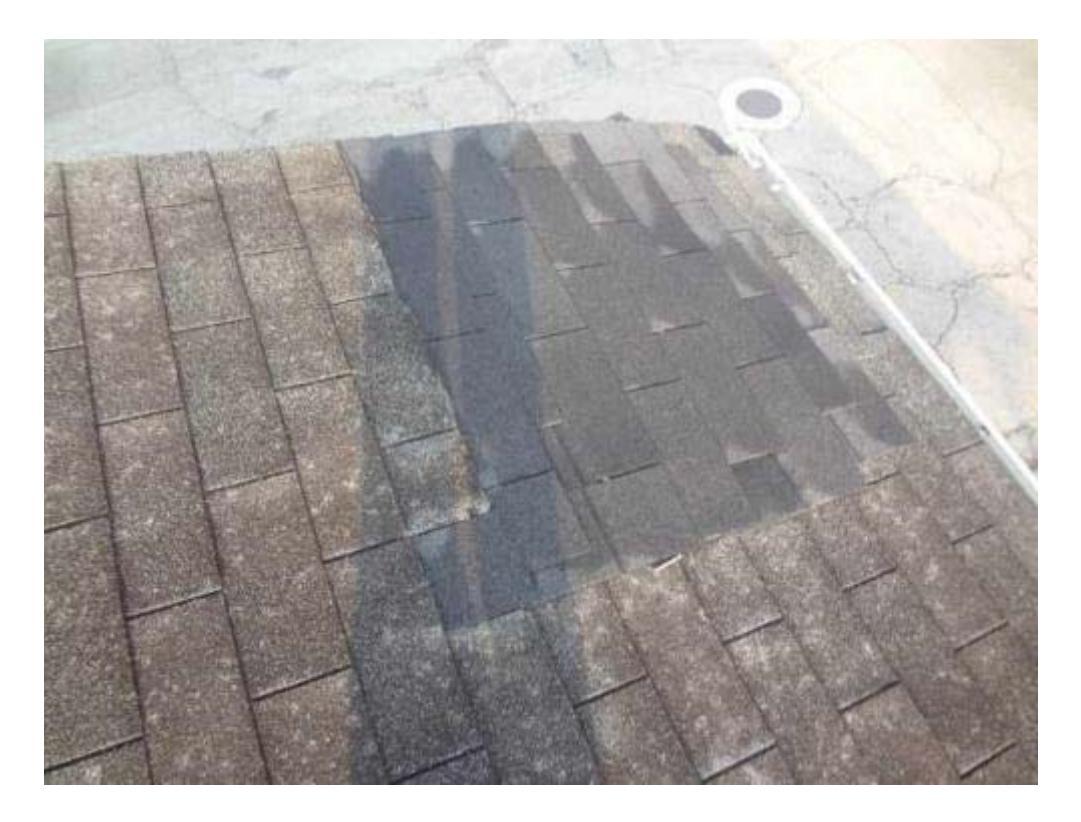
33 Loc 2 Left Slope

View of shingles that were temporarily installed to prevent further damage.

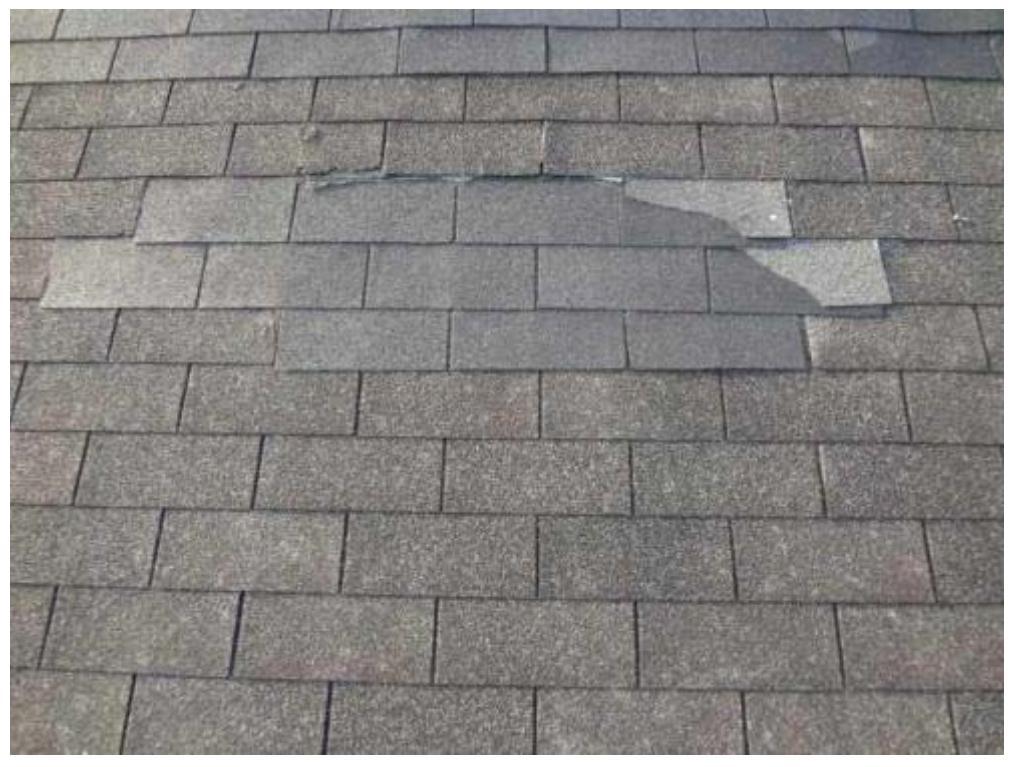
34 Loc 2 Left Slope Date Taken: 7/15/2012 Taken By: CSI Representative

> View of shingles that were temporarily installed to prevent further damage.

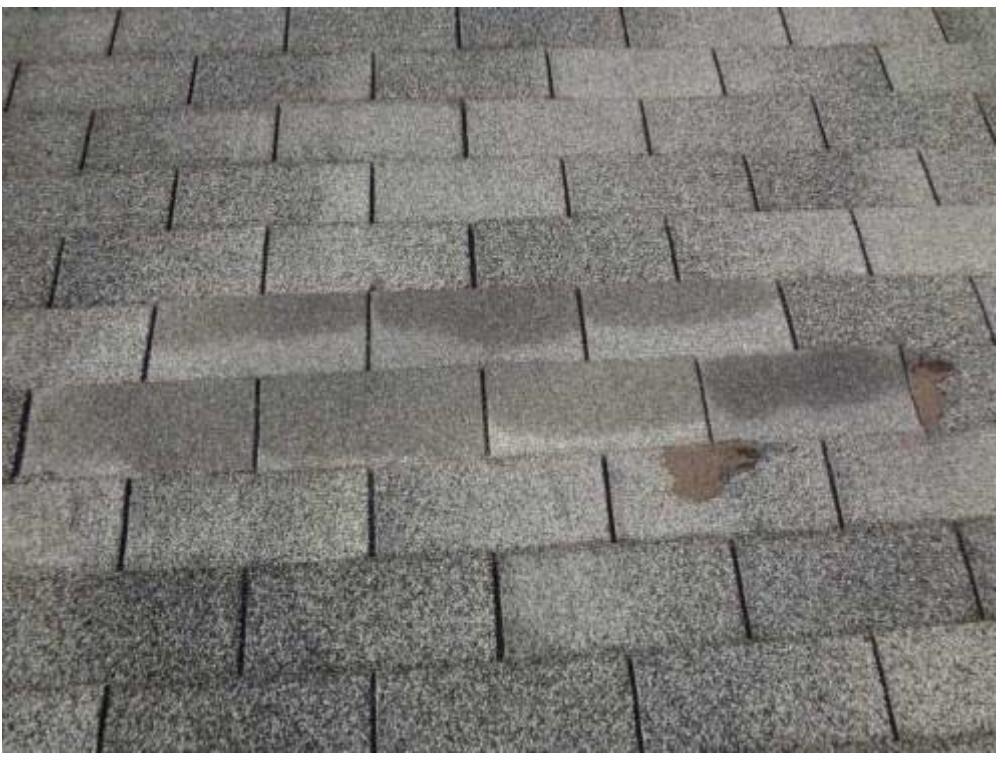
36 Loc 2 Right SlopeDate Taken: 7/15/2012Taken By: CSI Representative

View of shingles that were temporarily installed to prevent further damage.

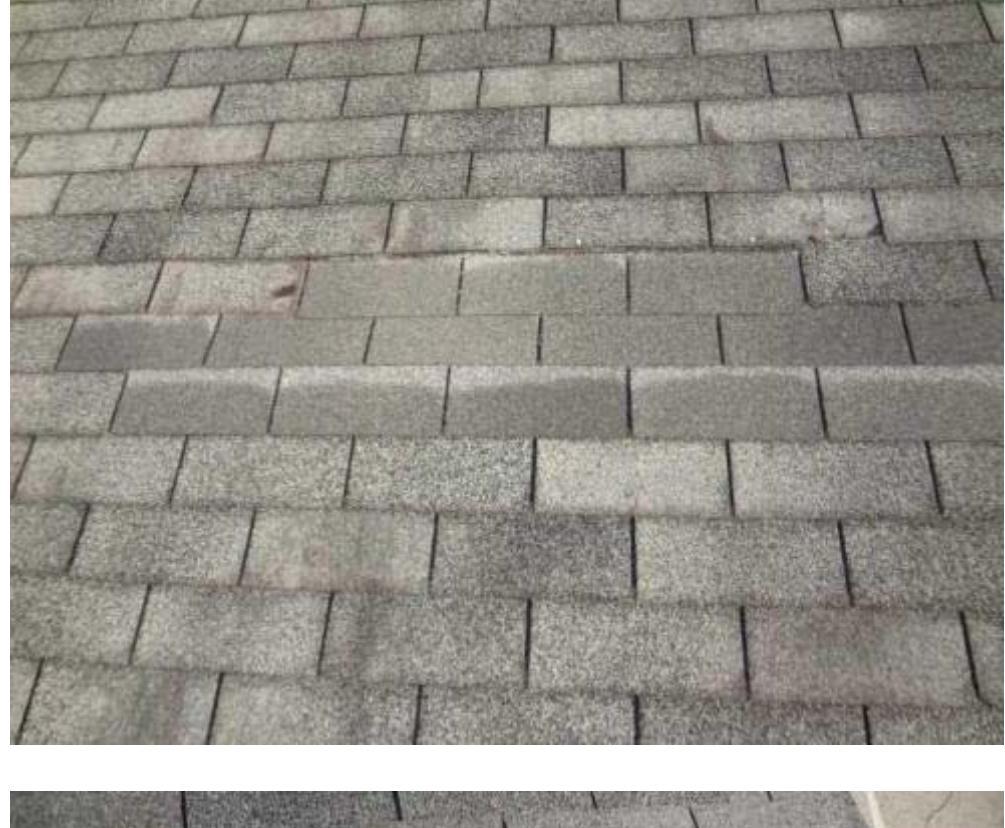
37 Loc 2 Right Slope Date Taken: 7/15/2012 Taken By: CSI Representative

> View of shingles that were temporarily installed to prevent further damage.

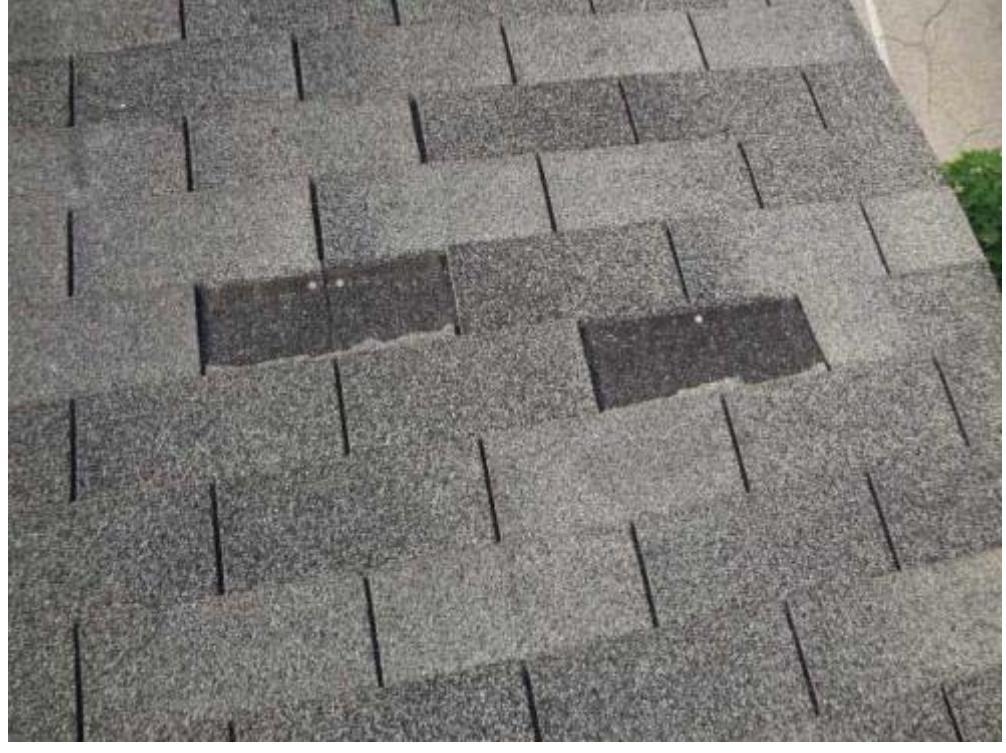
(4) Loc 2 Bldg 1 Roof: I began my inspection with the roof. The 2 story tall 16 year old 25 year 3-tab roof had hail and wind damage and it has been figured for replacement.

View of wind damage.
